## MACKAS SAND ANNUAL REVIEW 2024

January–December 2024

March 2025

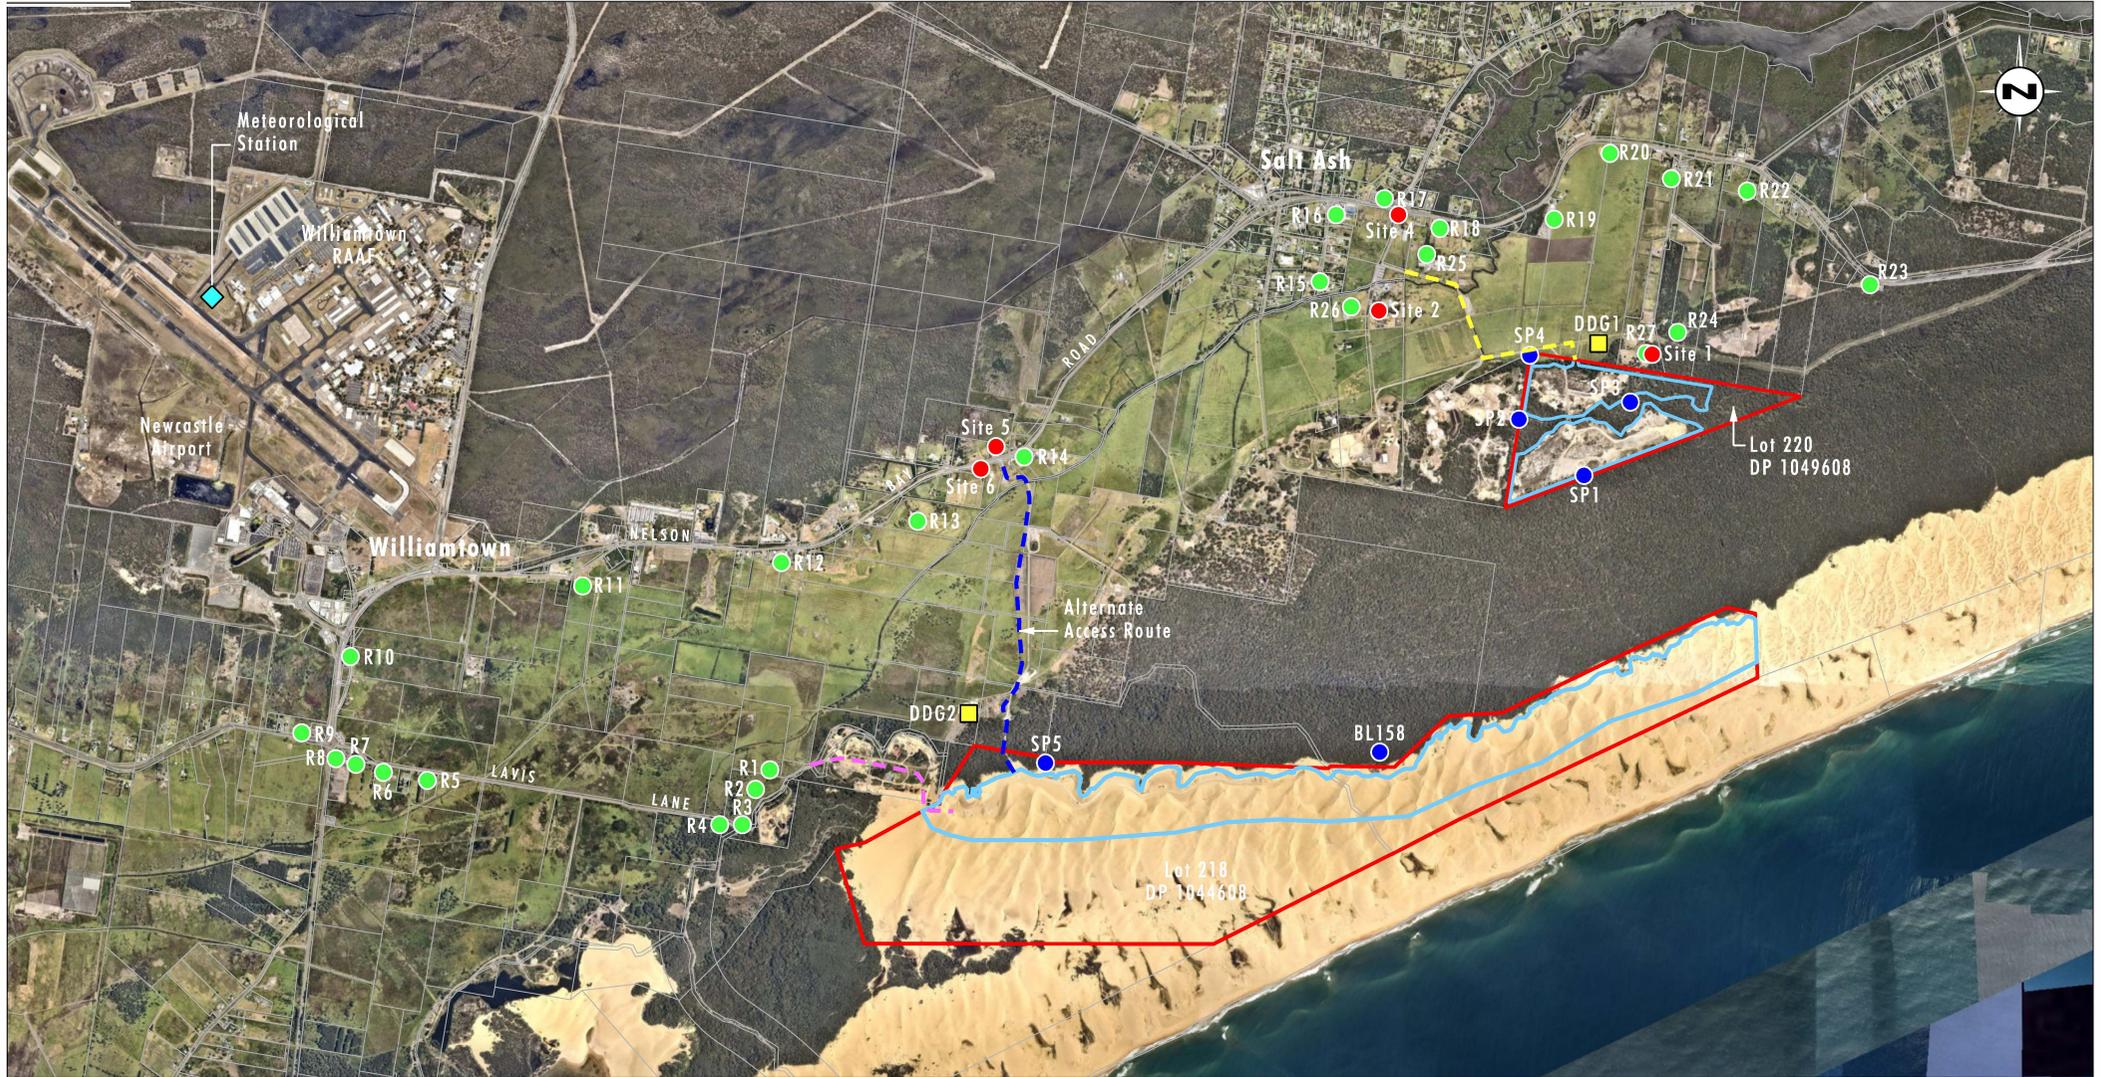
**Figure 6.1** shows the Mackas Sand environmental monitoring locations.

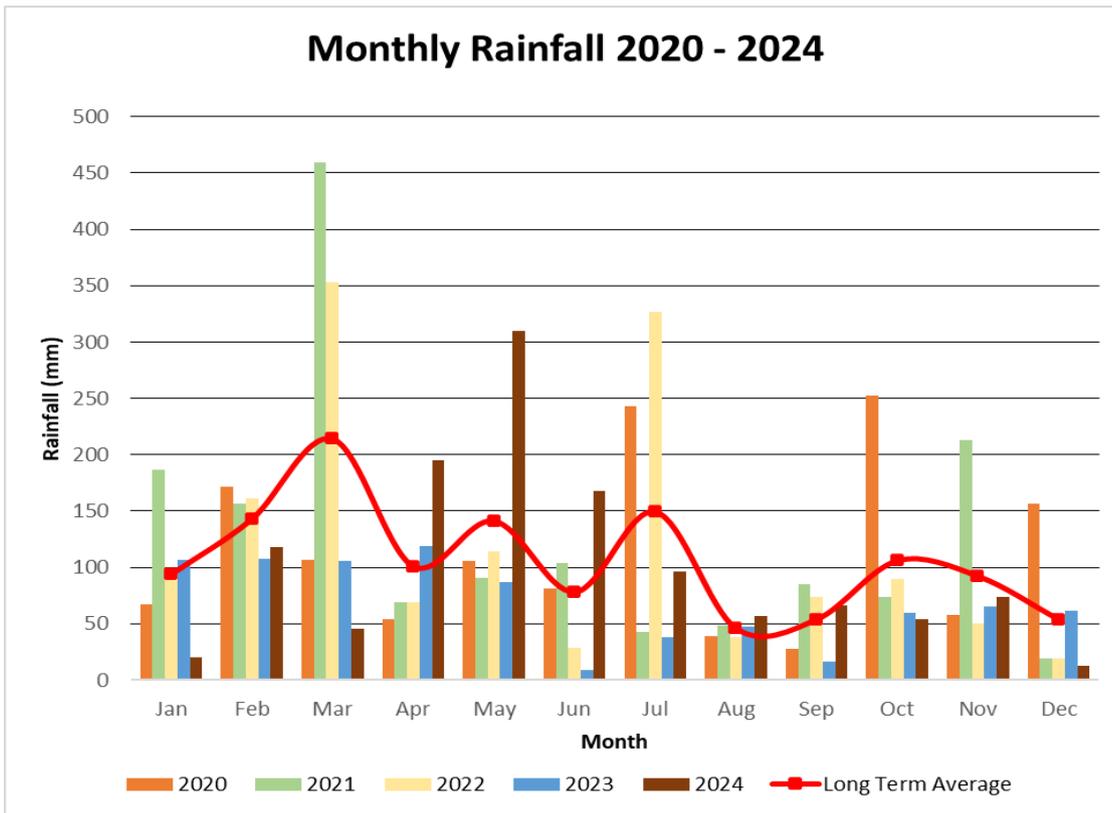
Figure 6.2 Monthly Rainfall 2020-2024

**Figure 6.2** provides a comparison of monthly rainfall from 2020–2024. During the reporting period, 1215 mm of rainfall was recorded across 175 rain days. Approximately 69% of the annual recorded rainfall for 2024 was experienced across February, March, April, May, and June.

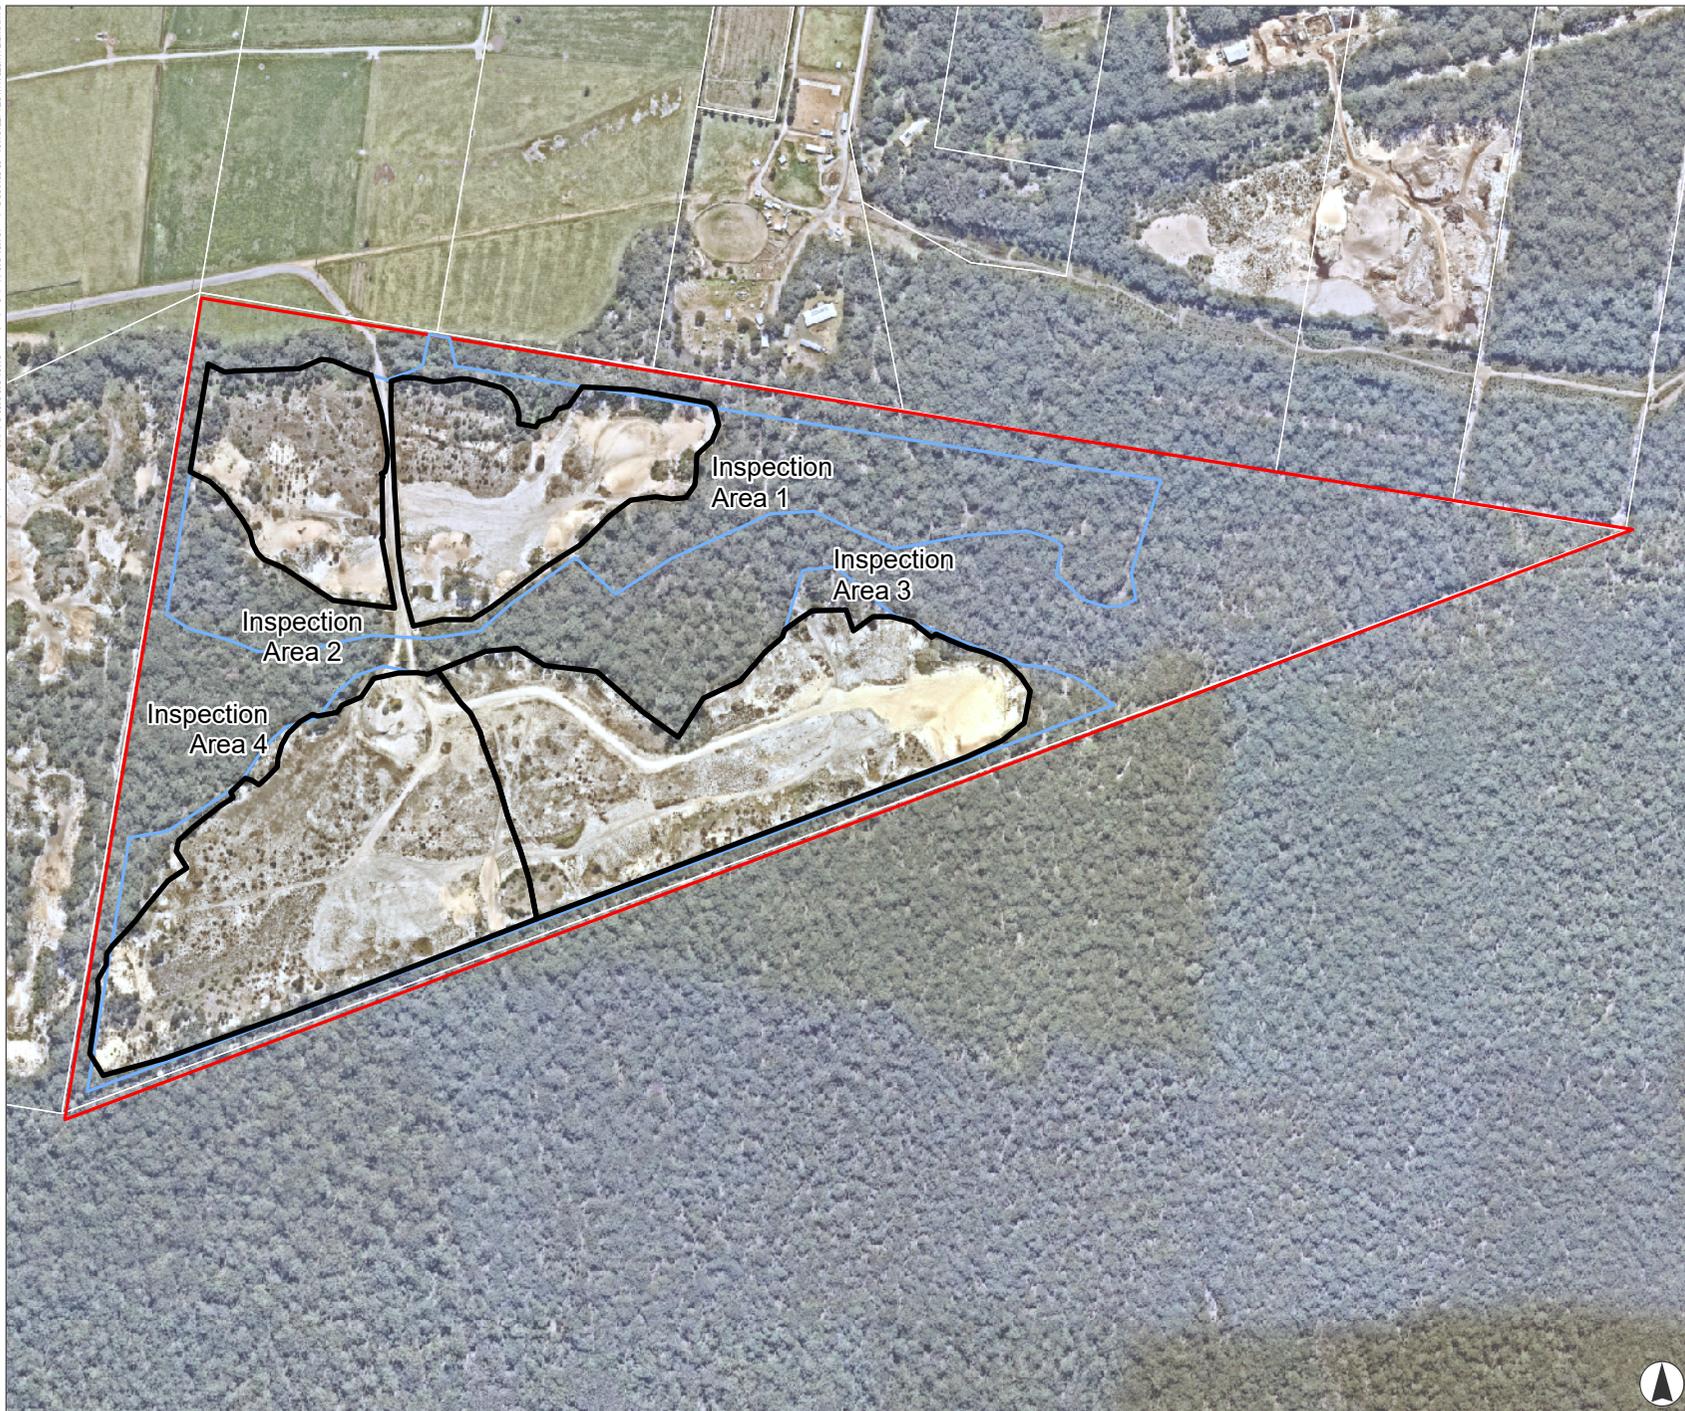
**FIGURE 2.1**  
**Lot 220 Rehabilitation and Inspection Areas**

- The need to remove redundant infrastructure including steel pipe, concrete blocks, conveyor belt and agricultural pipe located in the rehabilitation areas.

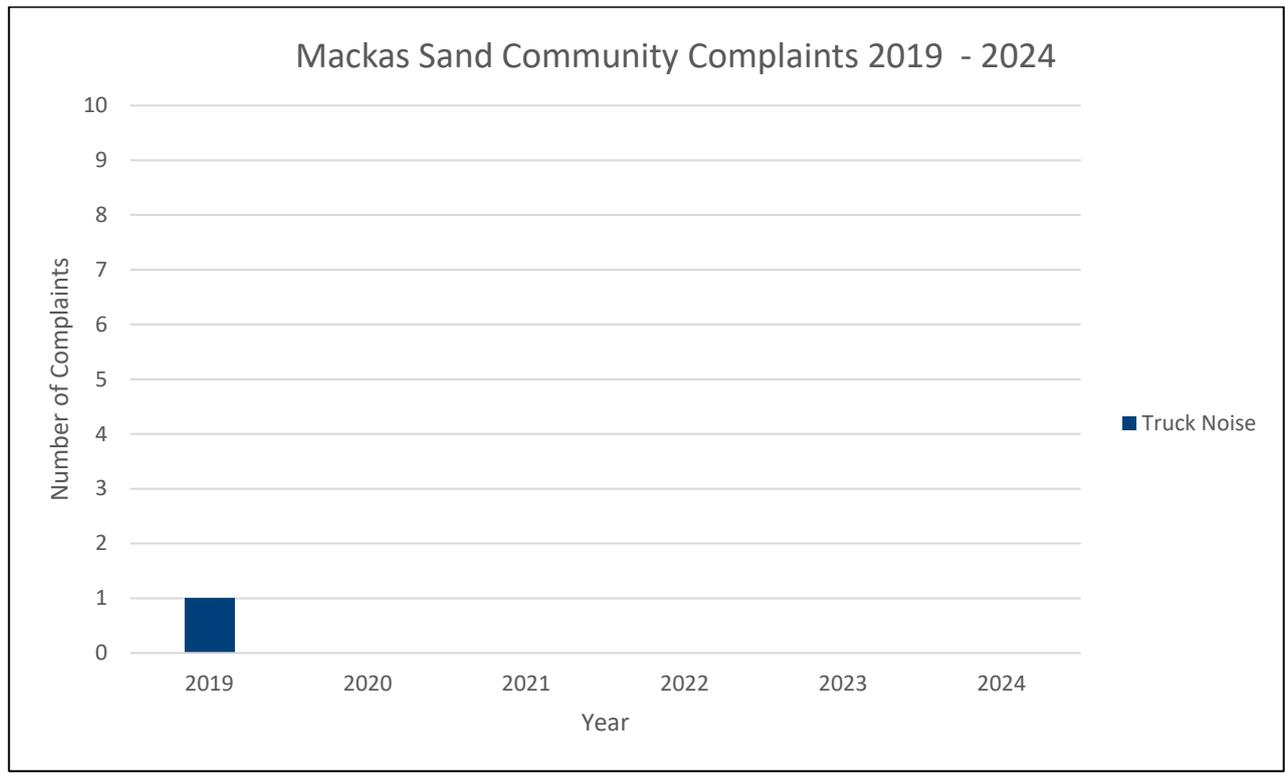
**Figure 9.1 Summary of Mackas Sand Community Complaints 2019 - 2024**

A summary of community complaints received for the last five reporting periods is displayed in **Figure 9.1**. It is noted that 1 community complaint has been received relating to truck noise between 2019 – 2024, but it did not occur during the 2024 reporting period.

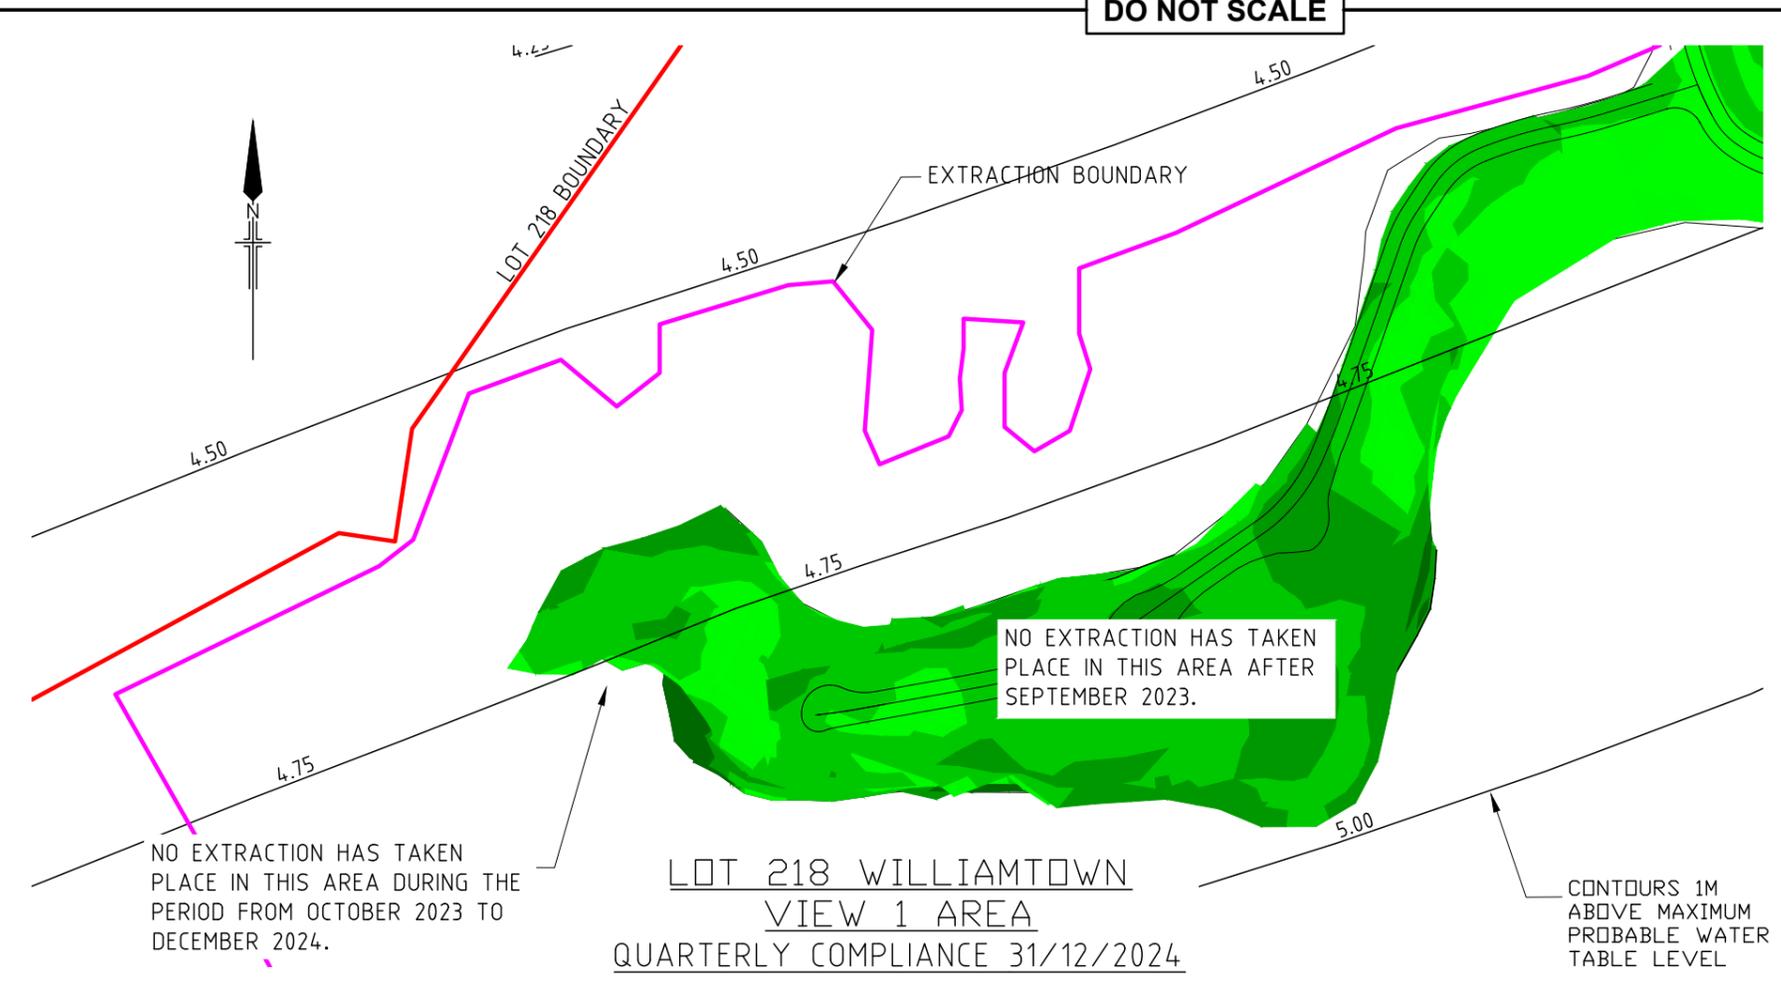
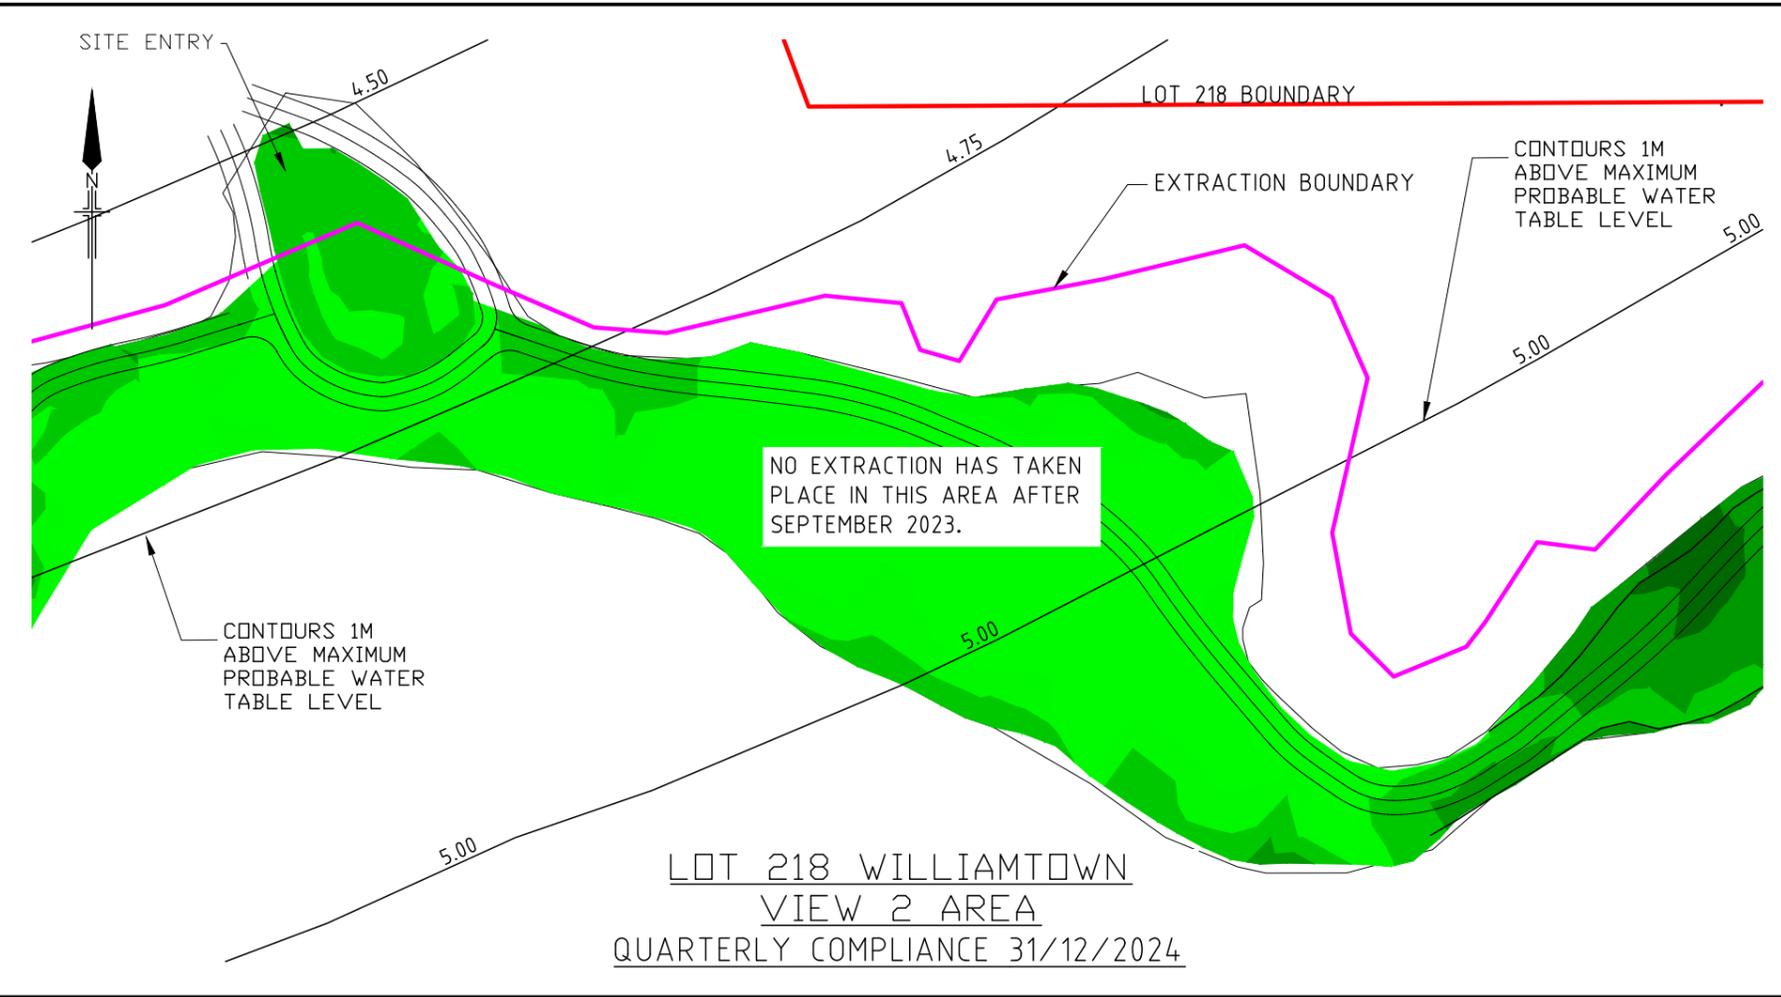
1. THE ROAD SURFACE LEVEL HAS BEEN RAISED TO A MINIMUM OF 300mm-400mm ABOVE THE EXTRACTION SURFACE.
2. THE SURFACE LEVEL EITHER SIDE OF THE ACCESS ROAD IN OPERATIONAL AREAS IS COMPLIANT AS AT 31/12/2024.
3. SHOT HEIGHTS SHOWN ARE FOR THE CURRENT OPERATIONAL FOOTPRINT AND CAN BE USED TO IDENTIFY THE EXTENT OF THE SURVEY.
4. AREAS WITHOUT SPOT HEIGHT SHOWN WERE IDENTIFIED AS COMPLYING IN PREVIOUS SURVEYS. THESE AREAS DO NOT FORM PART OF THE ACTIVE EXTRACTION OPERATION AND DO NOT FORM PART OF THIS SURVEY REPORT AND ARE ONLY SHOWN TO IDENTIFY THE CURRENT EXTENT OF THE EXTRACTION FLOOR.
5. SURVEY TO CONFIRM COMPLIANCE AT WESTERN END FOR THE QUARTER ENDING 31/12/2024 WAS COMPLETED 17/10/2023.
6. DATE OF CURRENT SURVEY: 10/01/2025

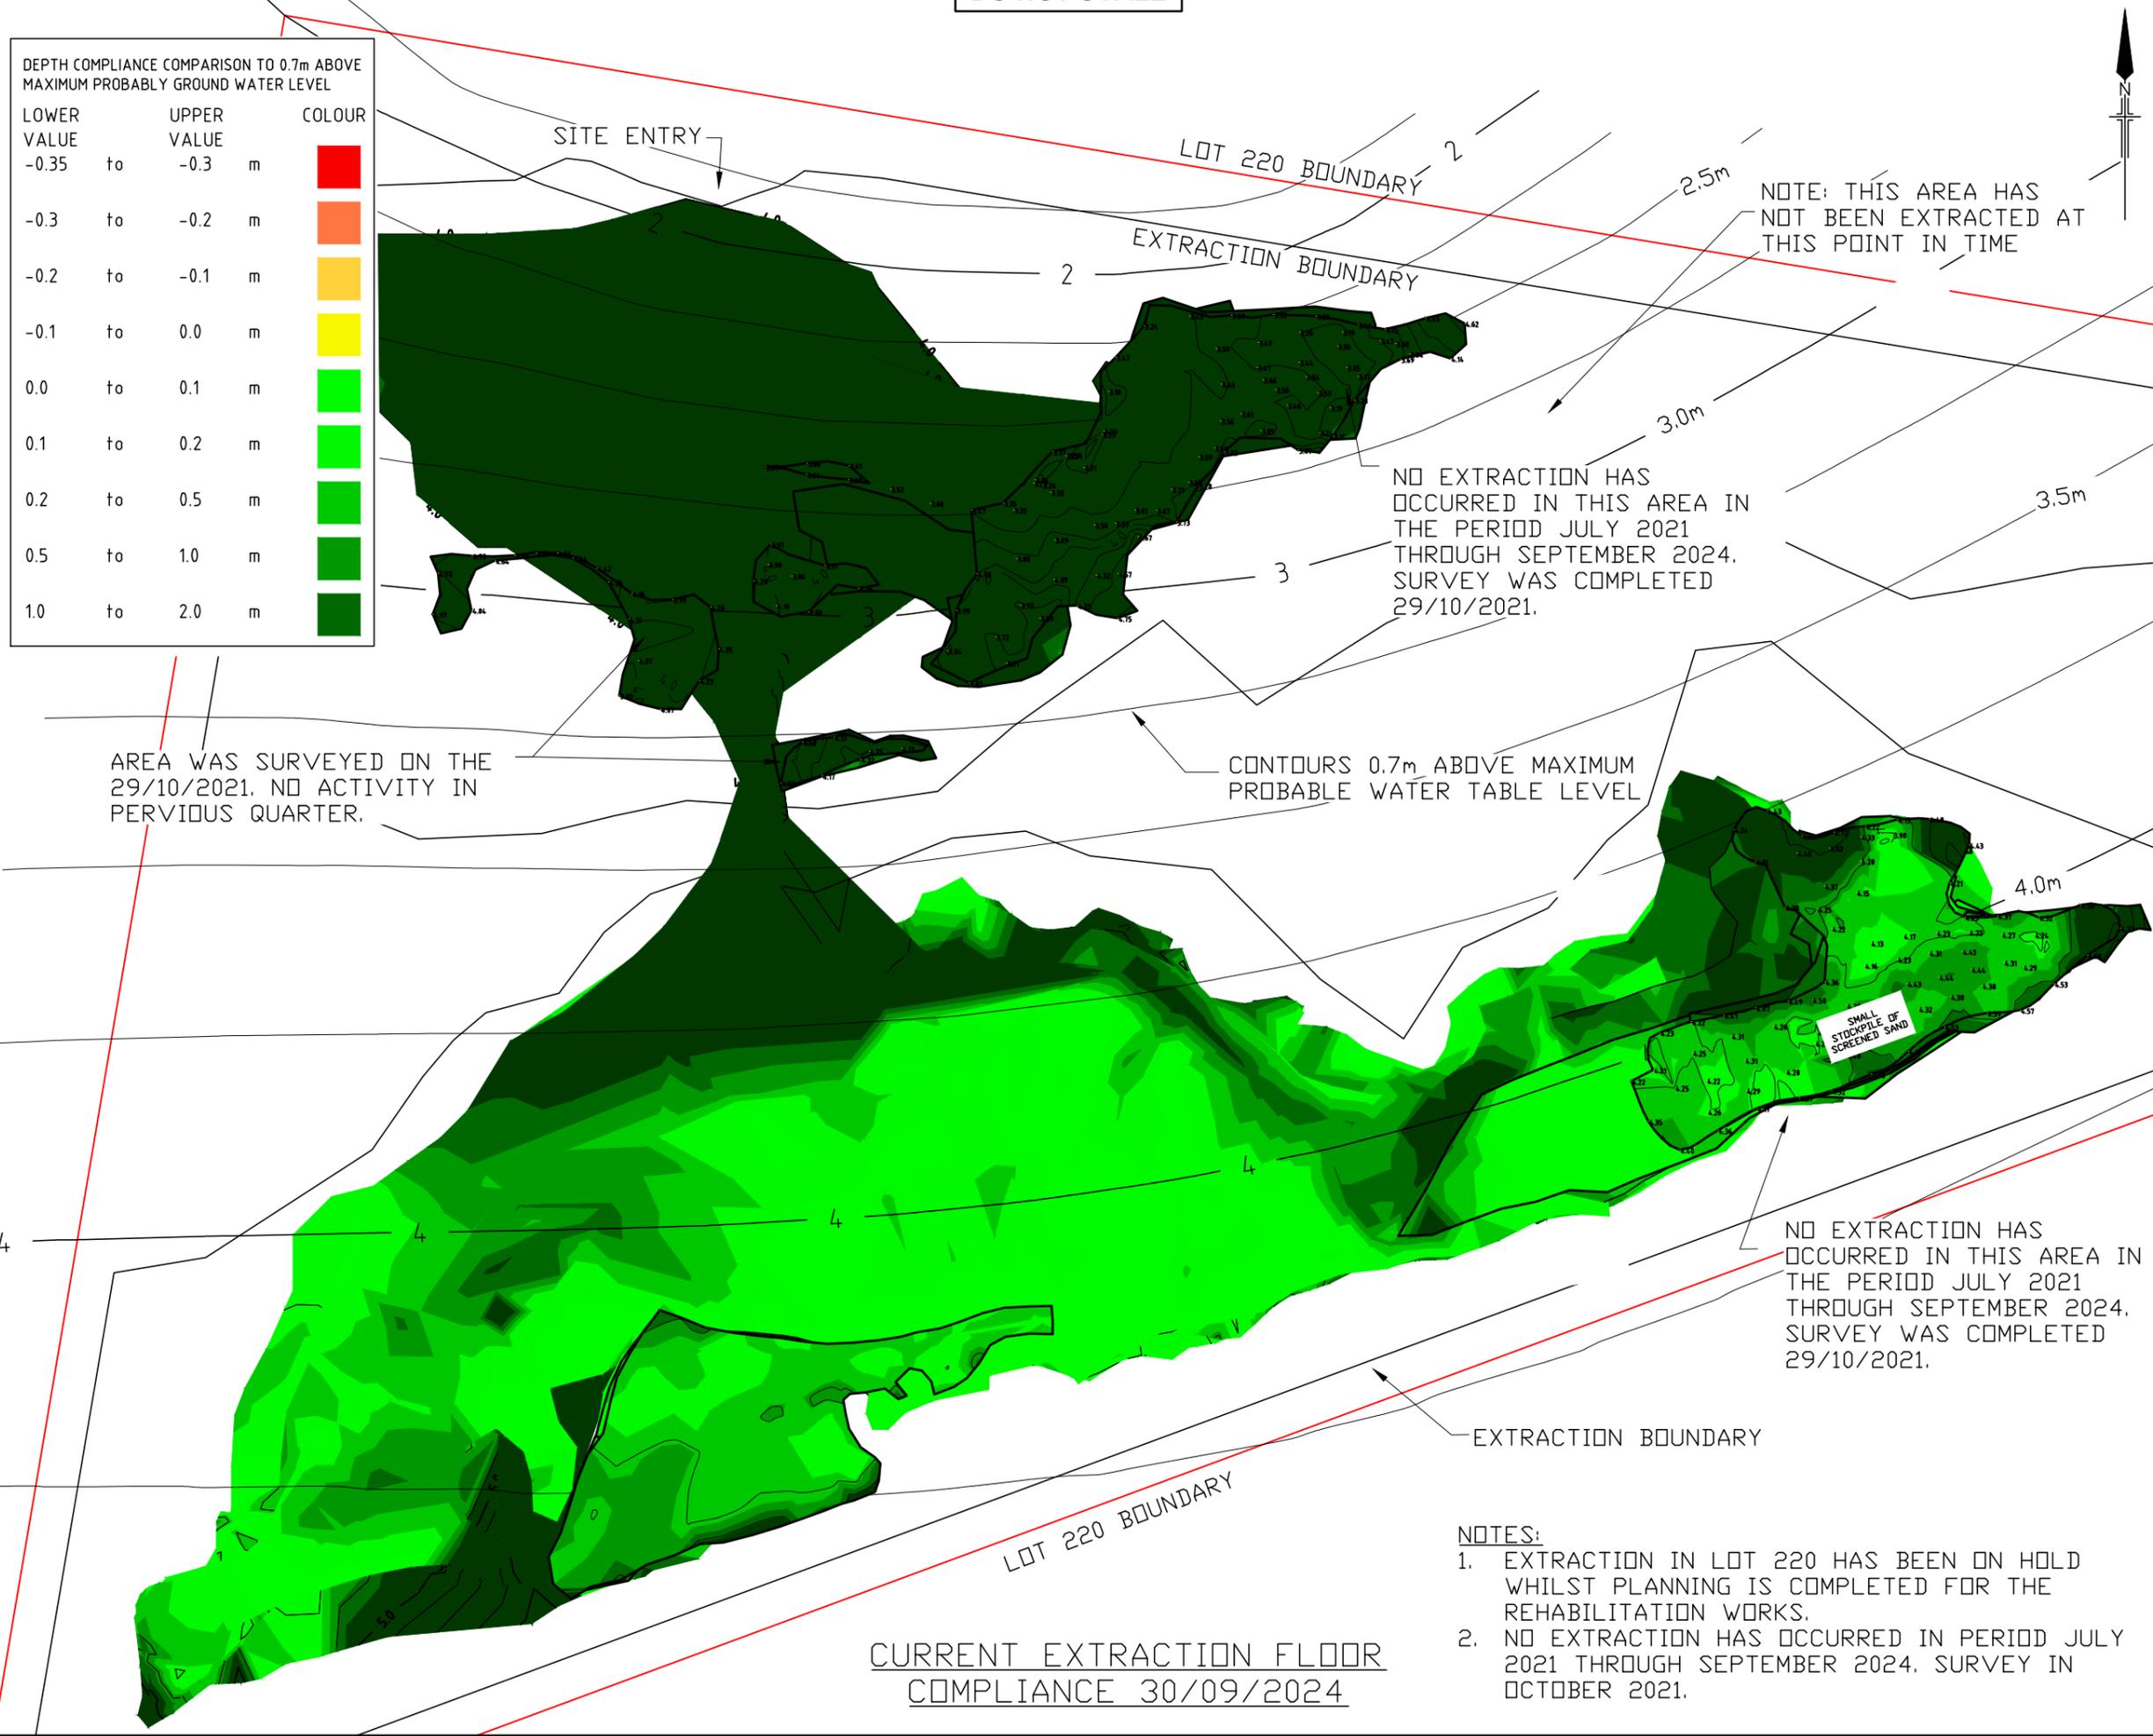
NOTE: THIS AREA HAS NOT BEEN EXTRACTED AT THIS POINT IN TIME

NO EXTRACTION HAS OCCURRED IN THIS AREA IN THE PERIOD JULY 2021 THROUGH SEPTEMBER 2024. SURVEY WAS COMPLETED 29/10/2021.

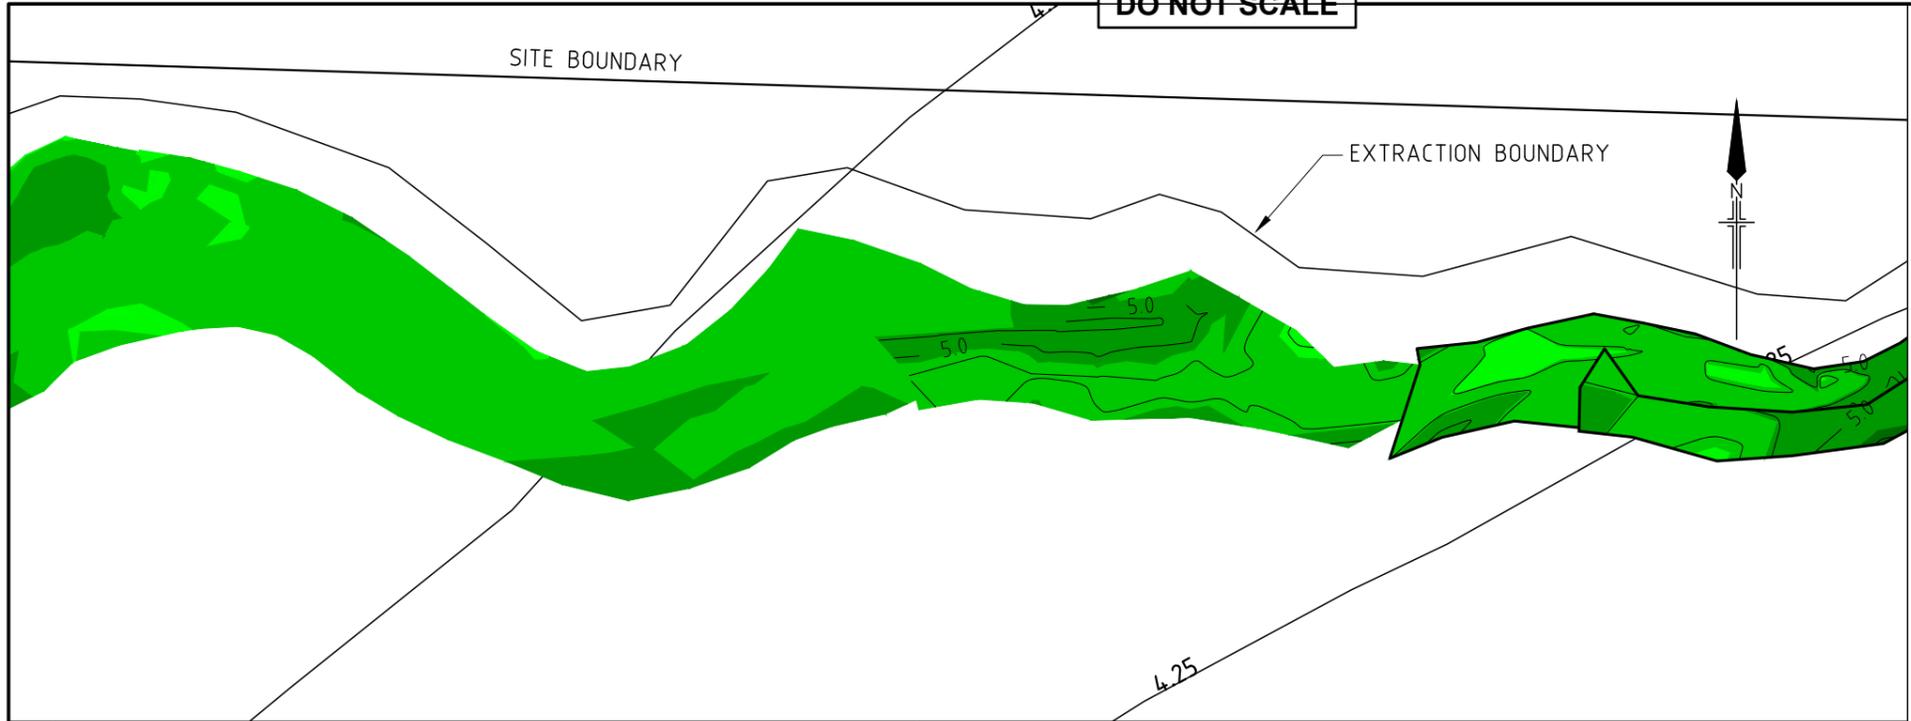
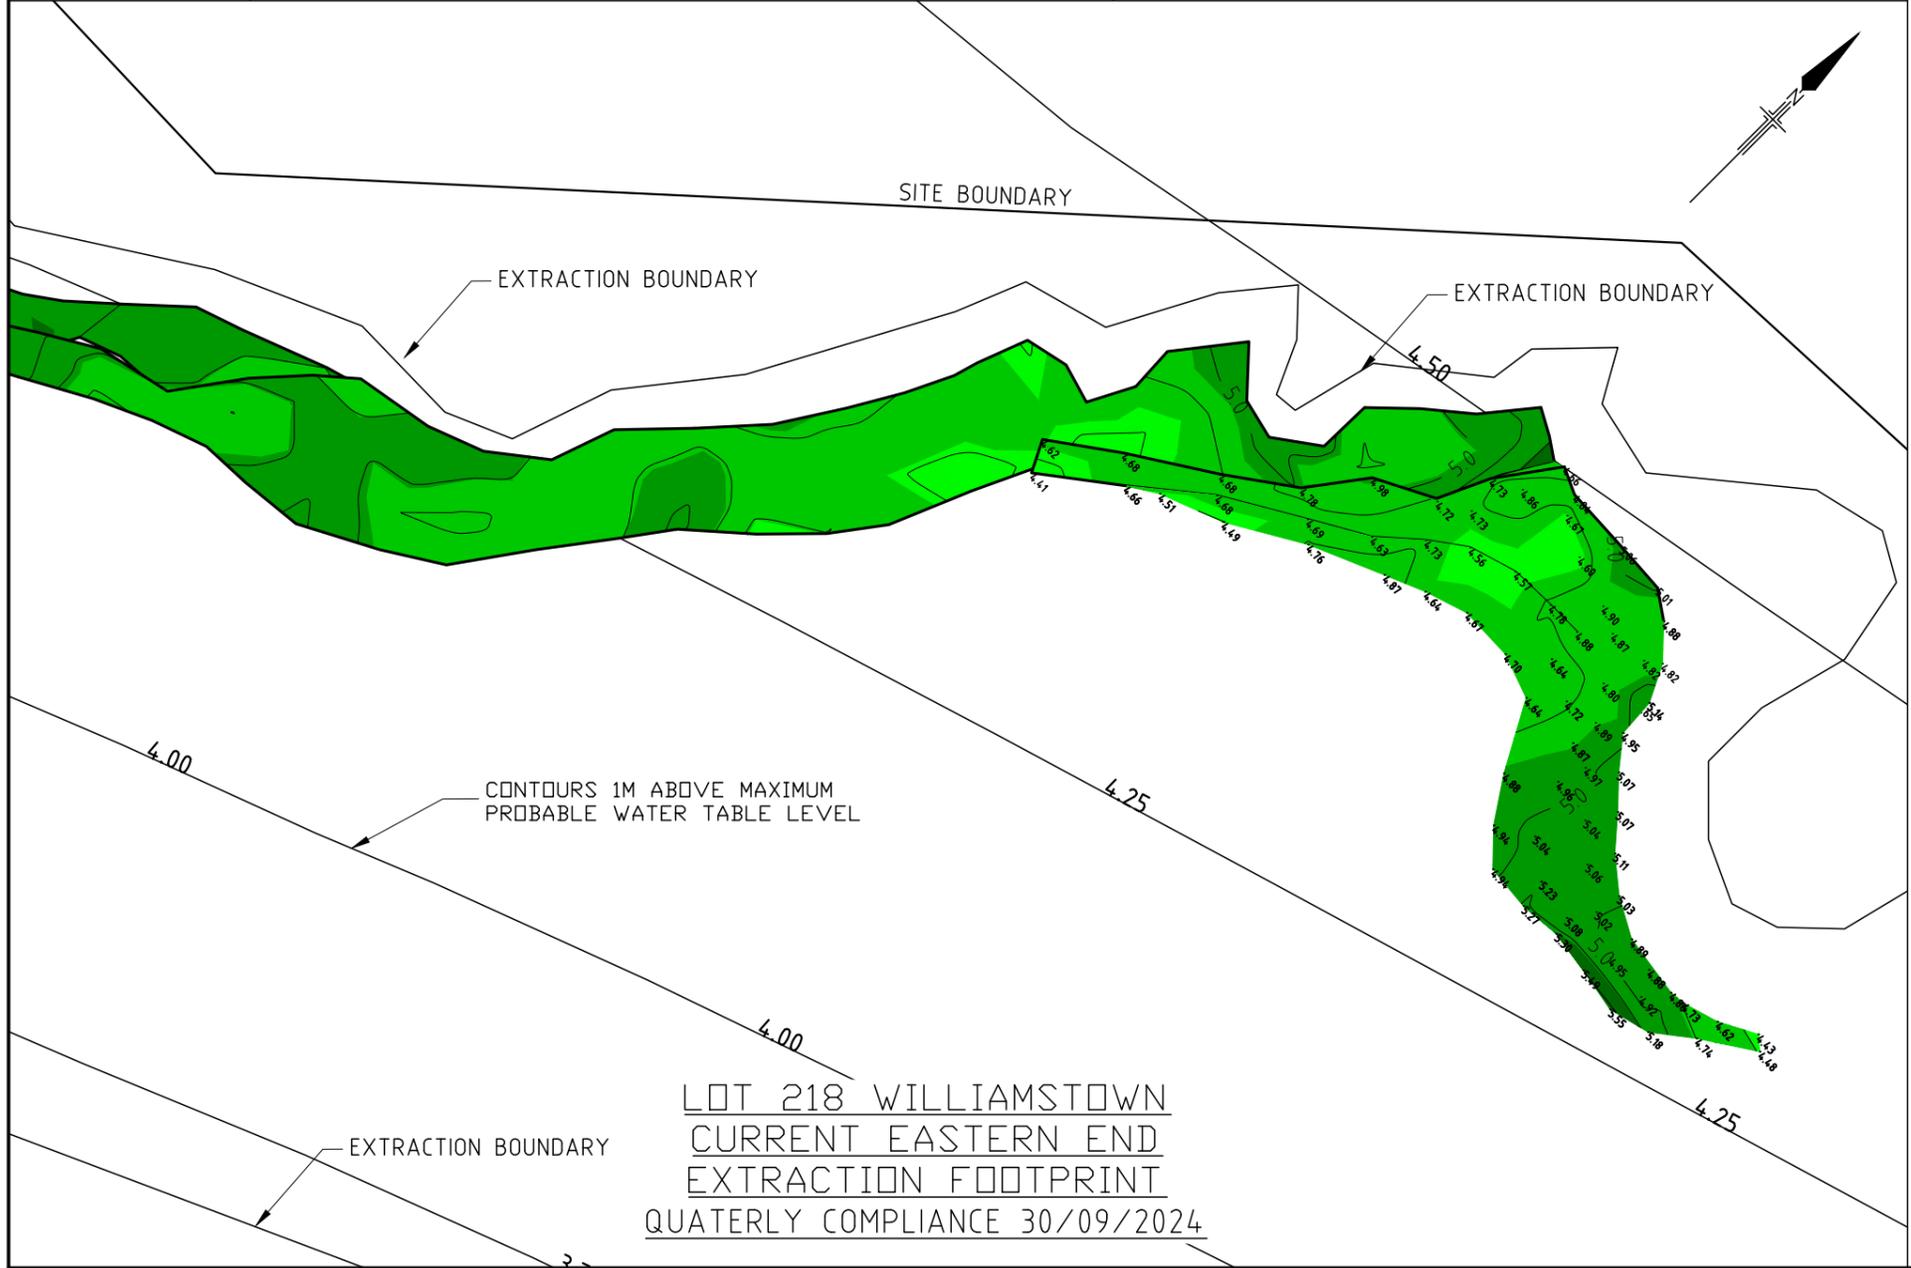
1. THE ROAD SURFACE LEVEL HAS BEEN RAISED TO A MINIMUM OF 300mm-400mm ABOVE THE EXTRACTION SURFACE.
2. THE SURFACE LEVEL EITHER SIDE OF THE ACCESS ROAD IN OPERATIONAL AREAS IS COMPLIANT AS AT 30/09/2024.
3. SHOT HEIGHTS SHOWN ARE FOR THE CURRENT OPERATIONAL AREAS AND CAN BE USED TO IDENTIFY THE EXTENT OF THE SURVEY. OTHER AREAS WHERE IDENTIFIED AS COMPLIANT IN PREVIOUS SURVEYS. THESE AREAS DO NOT FORM PART OF THE ACTIVE EXTRACTION OPERATION.
4. SURVEY TO CONFIRM COMPLIANCE AT EASTERN END FOR THE QUARTER ENDING 30/09/2024 WAS COMPLETED 27/09/2024.

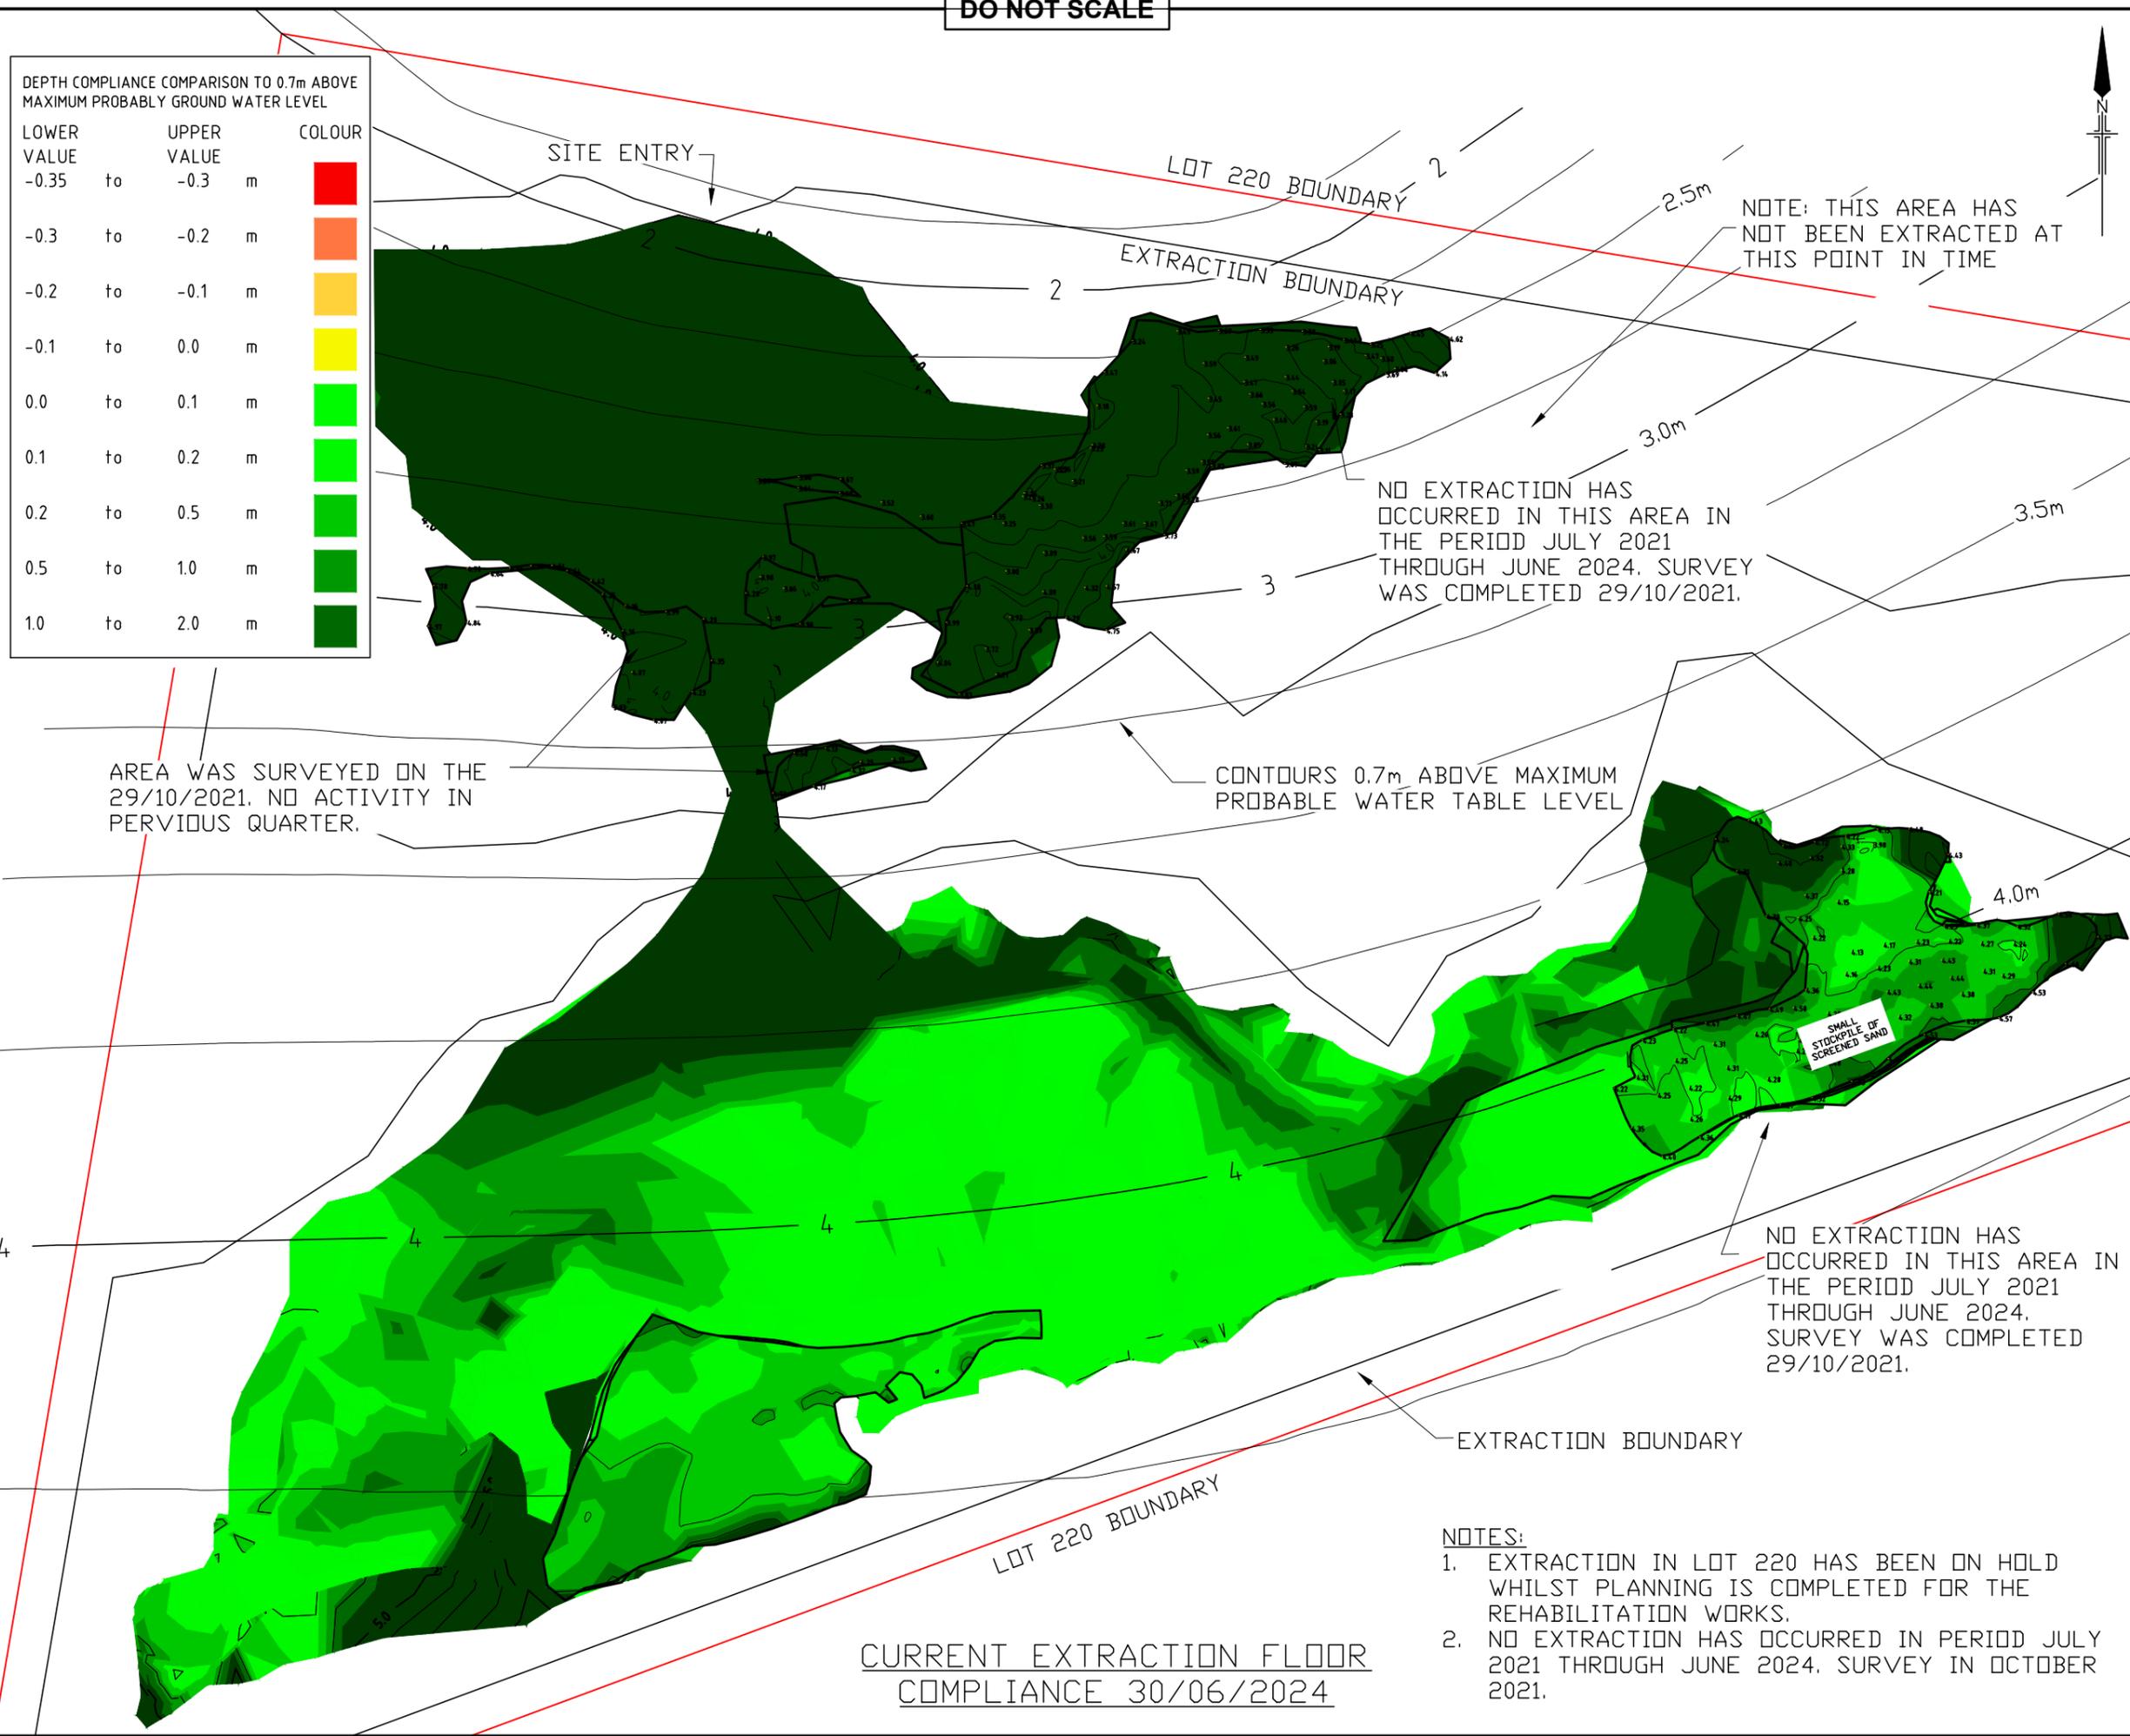
NOTE: THIS AREA HAS NOT BEEN EXTRACTED AT THIS POINT IN TIME

NO EXTRACTION HAS OCCURRED IN THIS AREA IN THE PERIOD JULY 2021 THROUGH JUNE 2024. SURVEY WAS COMPLETED 29/10/2021.
