## MACKAS SAND ANNUAL REVIEW 2024

January–December 2024

March 2025

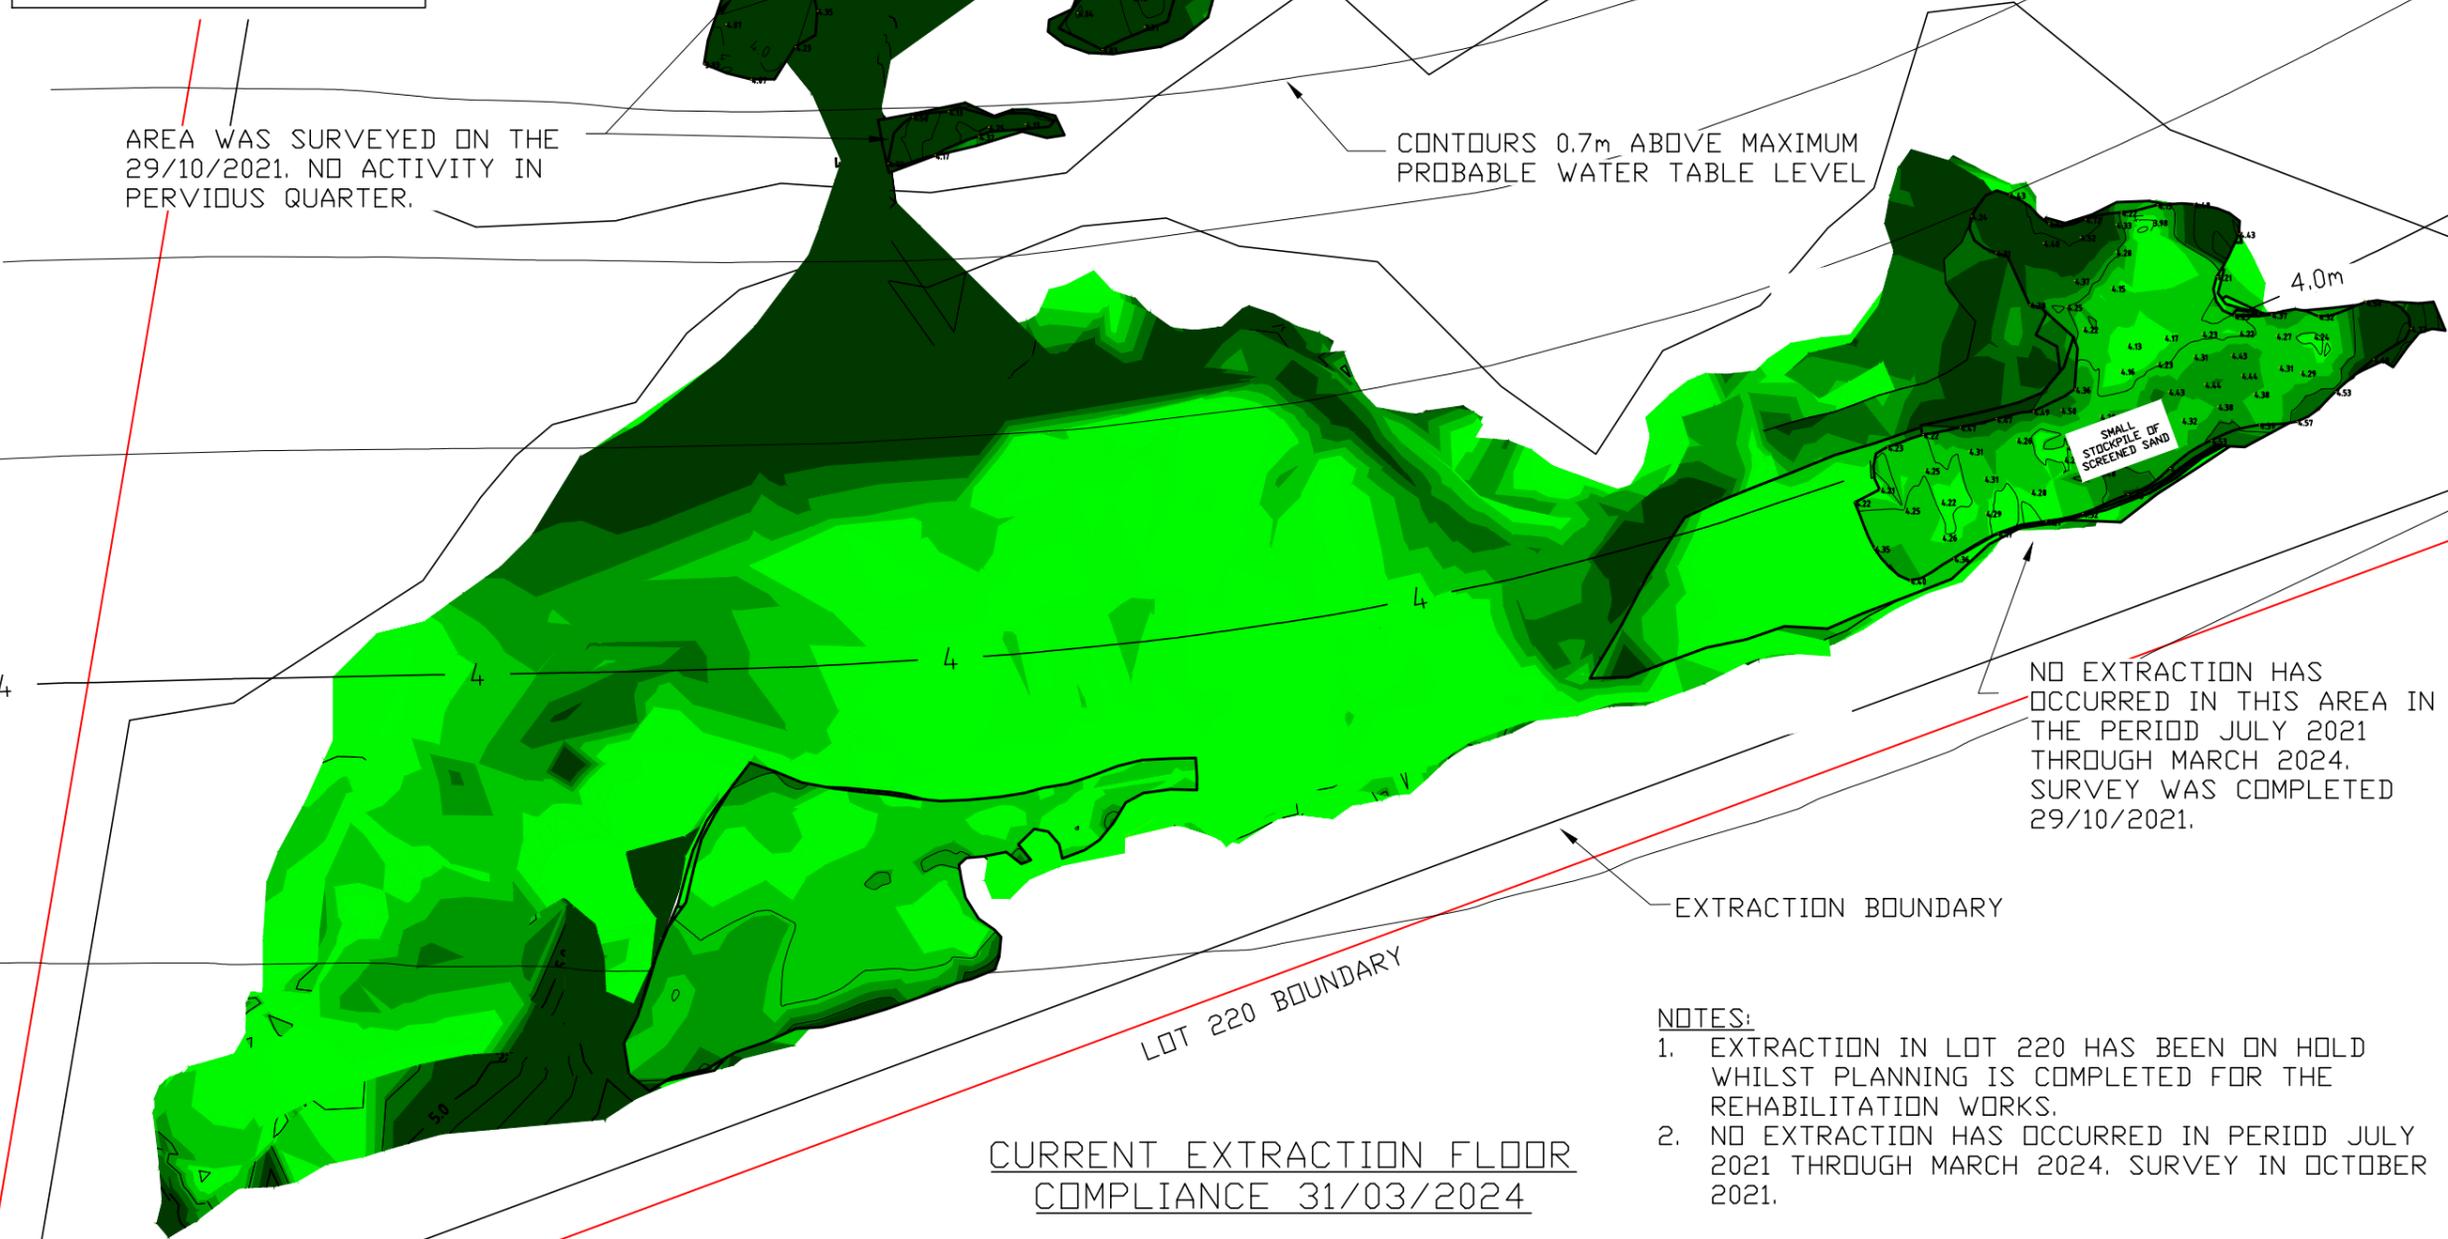
NOTE: THIS AREA HAS NOT BEEN EXTRACTED AT THIS POINT IN TIME

NO EXTRACTION HAS OCCURRED IN THIS AREA IN THE PERIOD JULY 2021 THROUGH MARCH 2024. SURVEY WAS COMPLETED 29/10/2021.

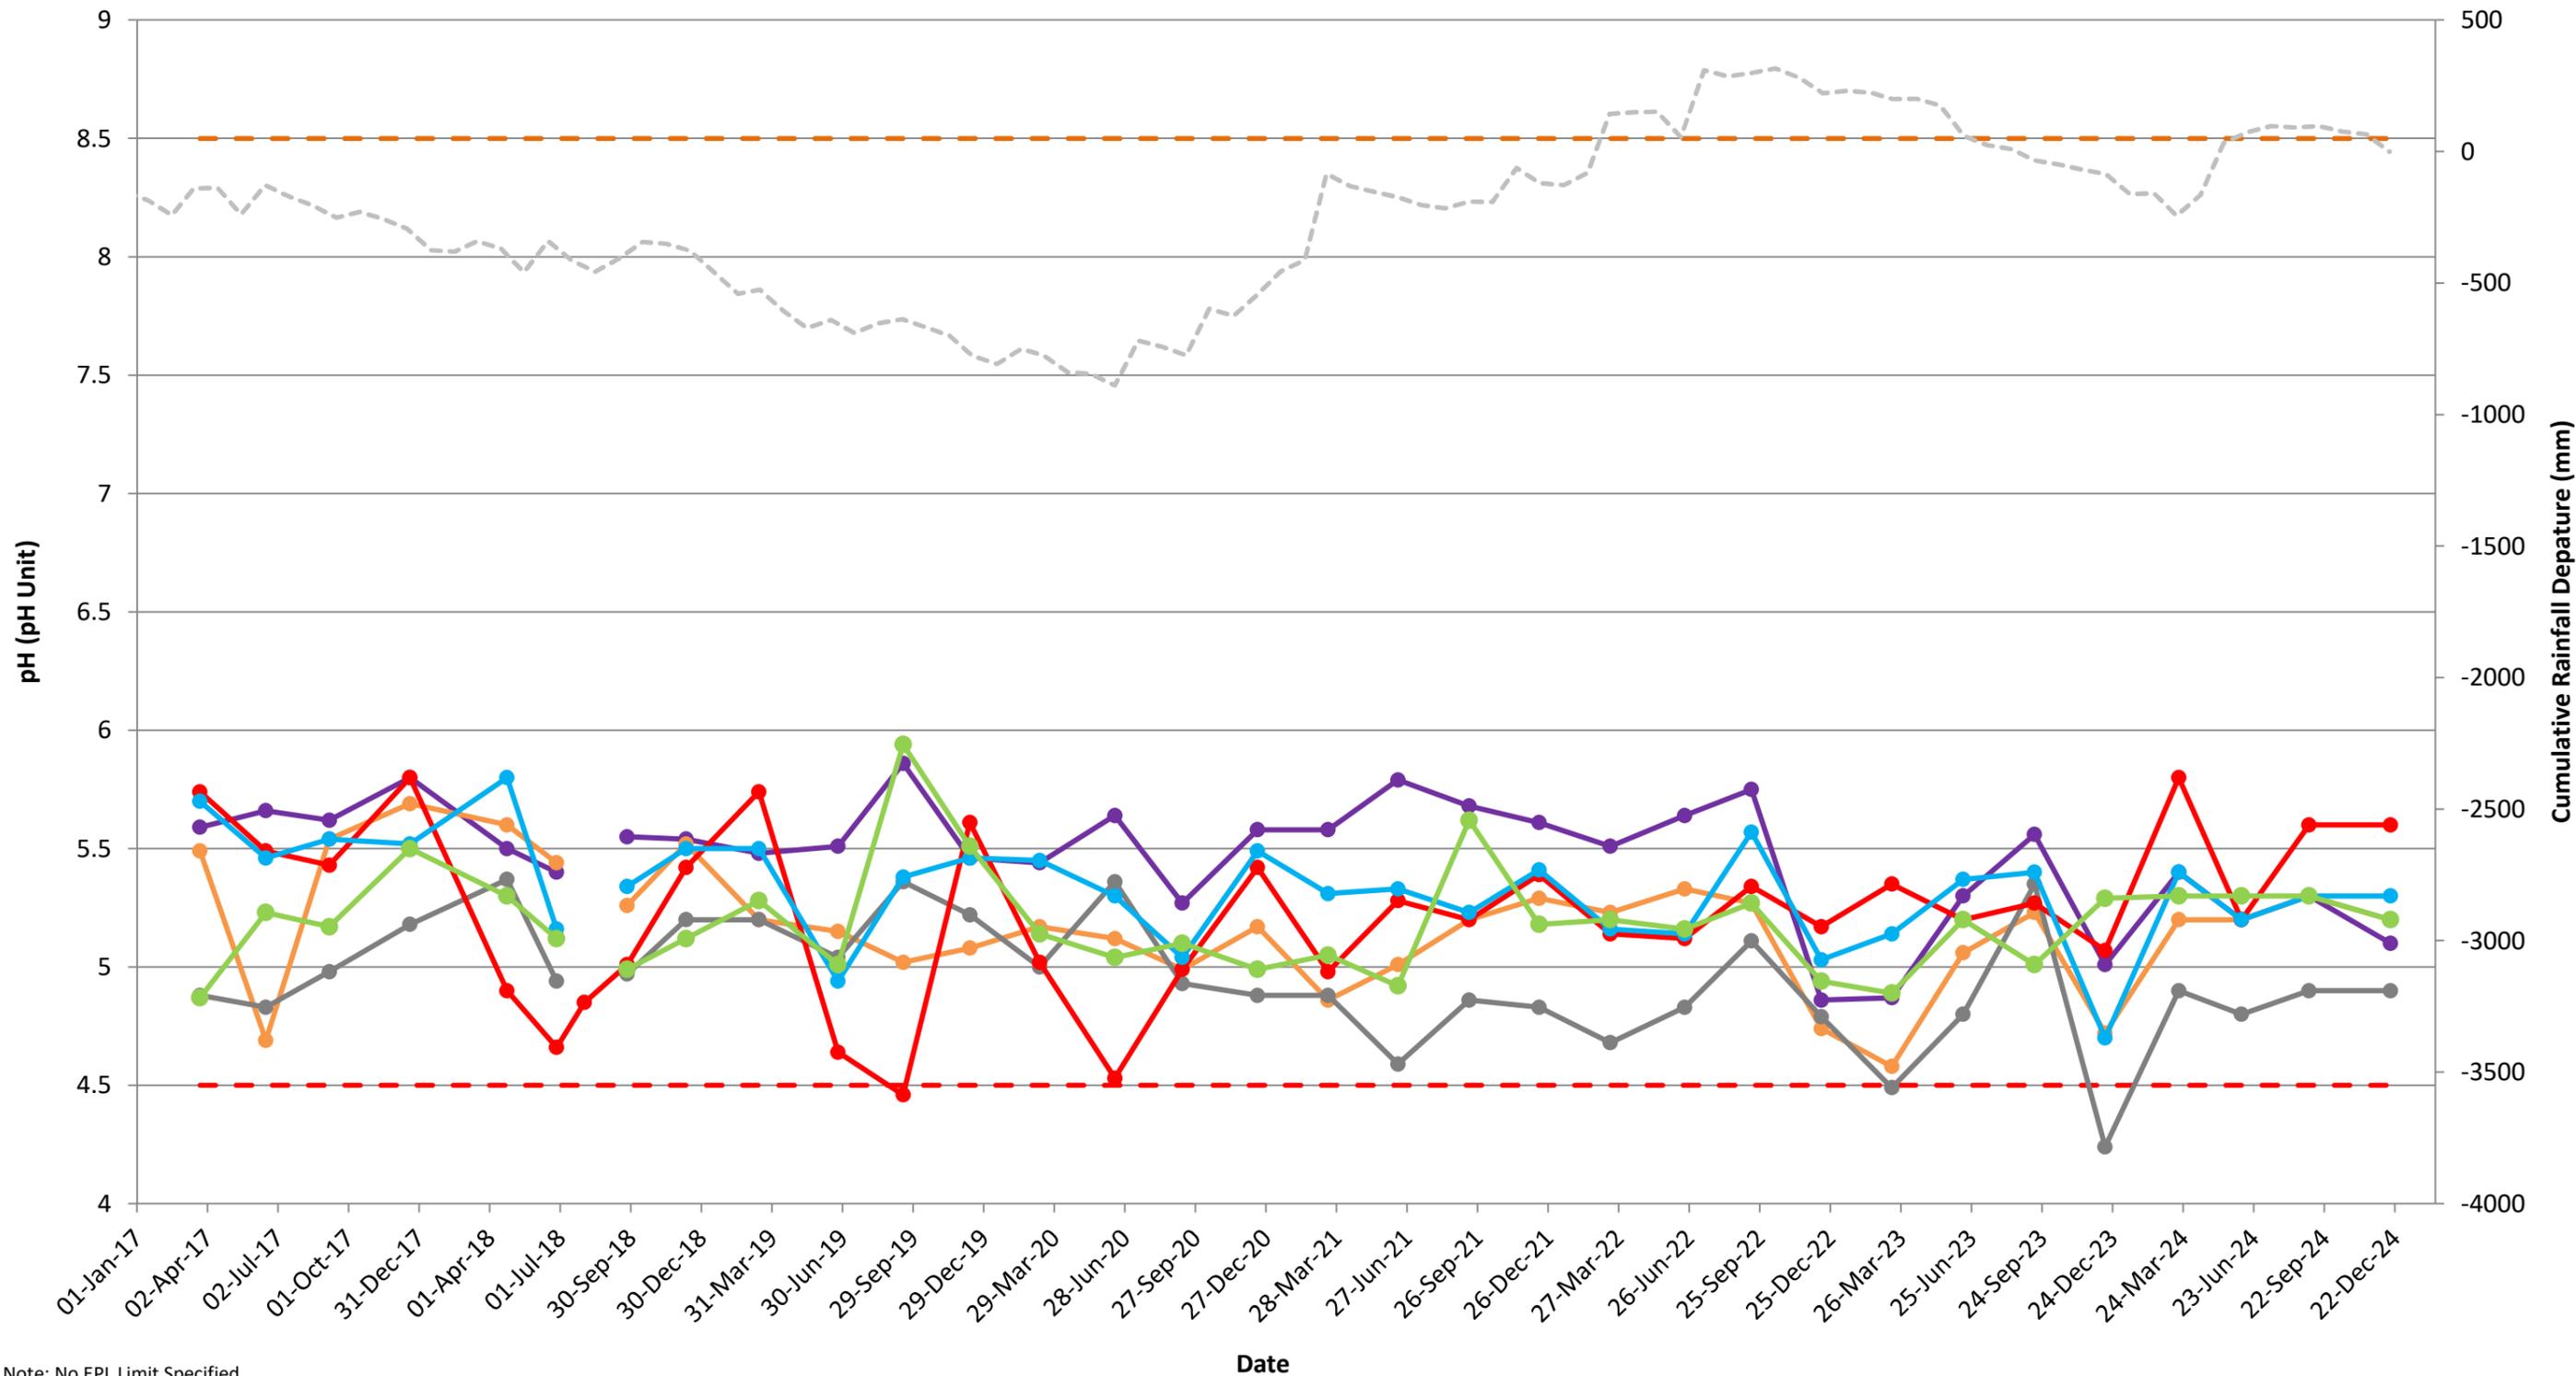
### Groundwater - pH

Note: No EPL Limit Specified

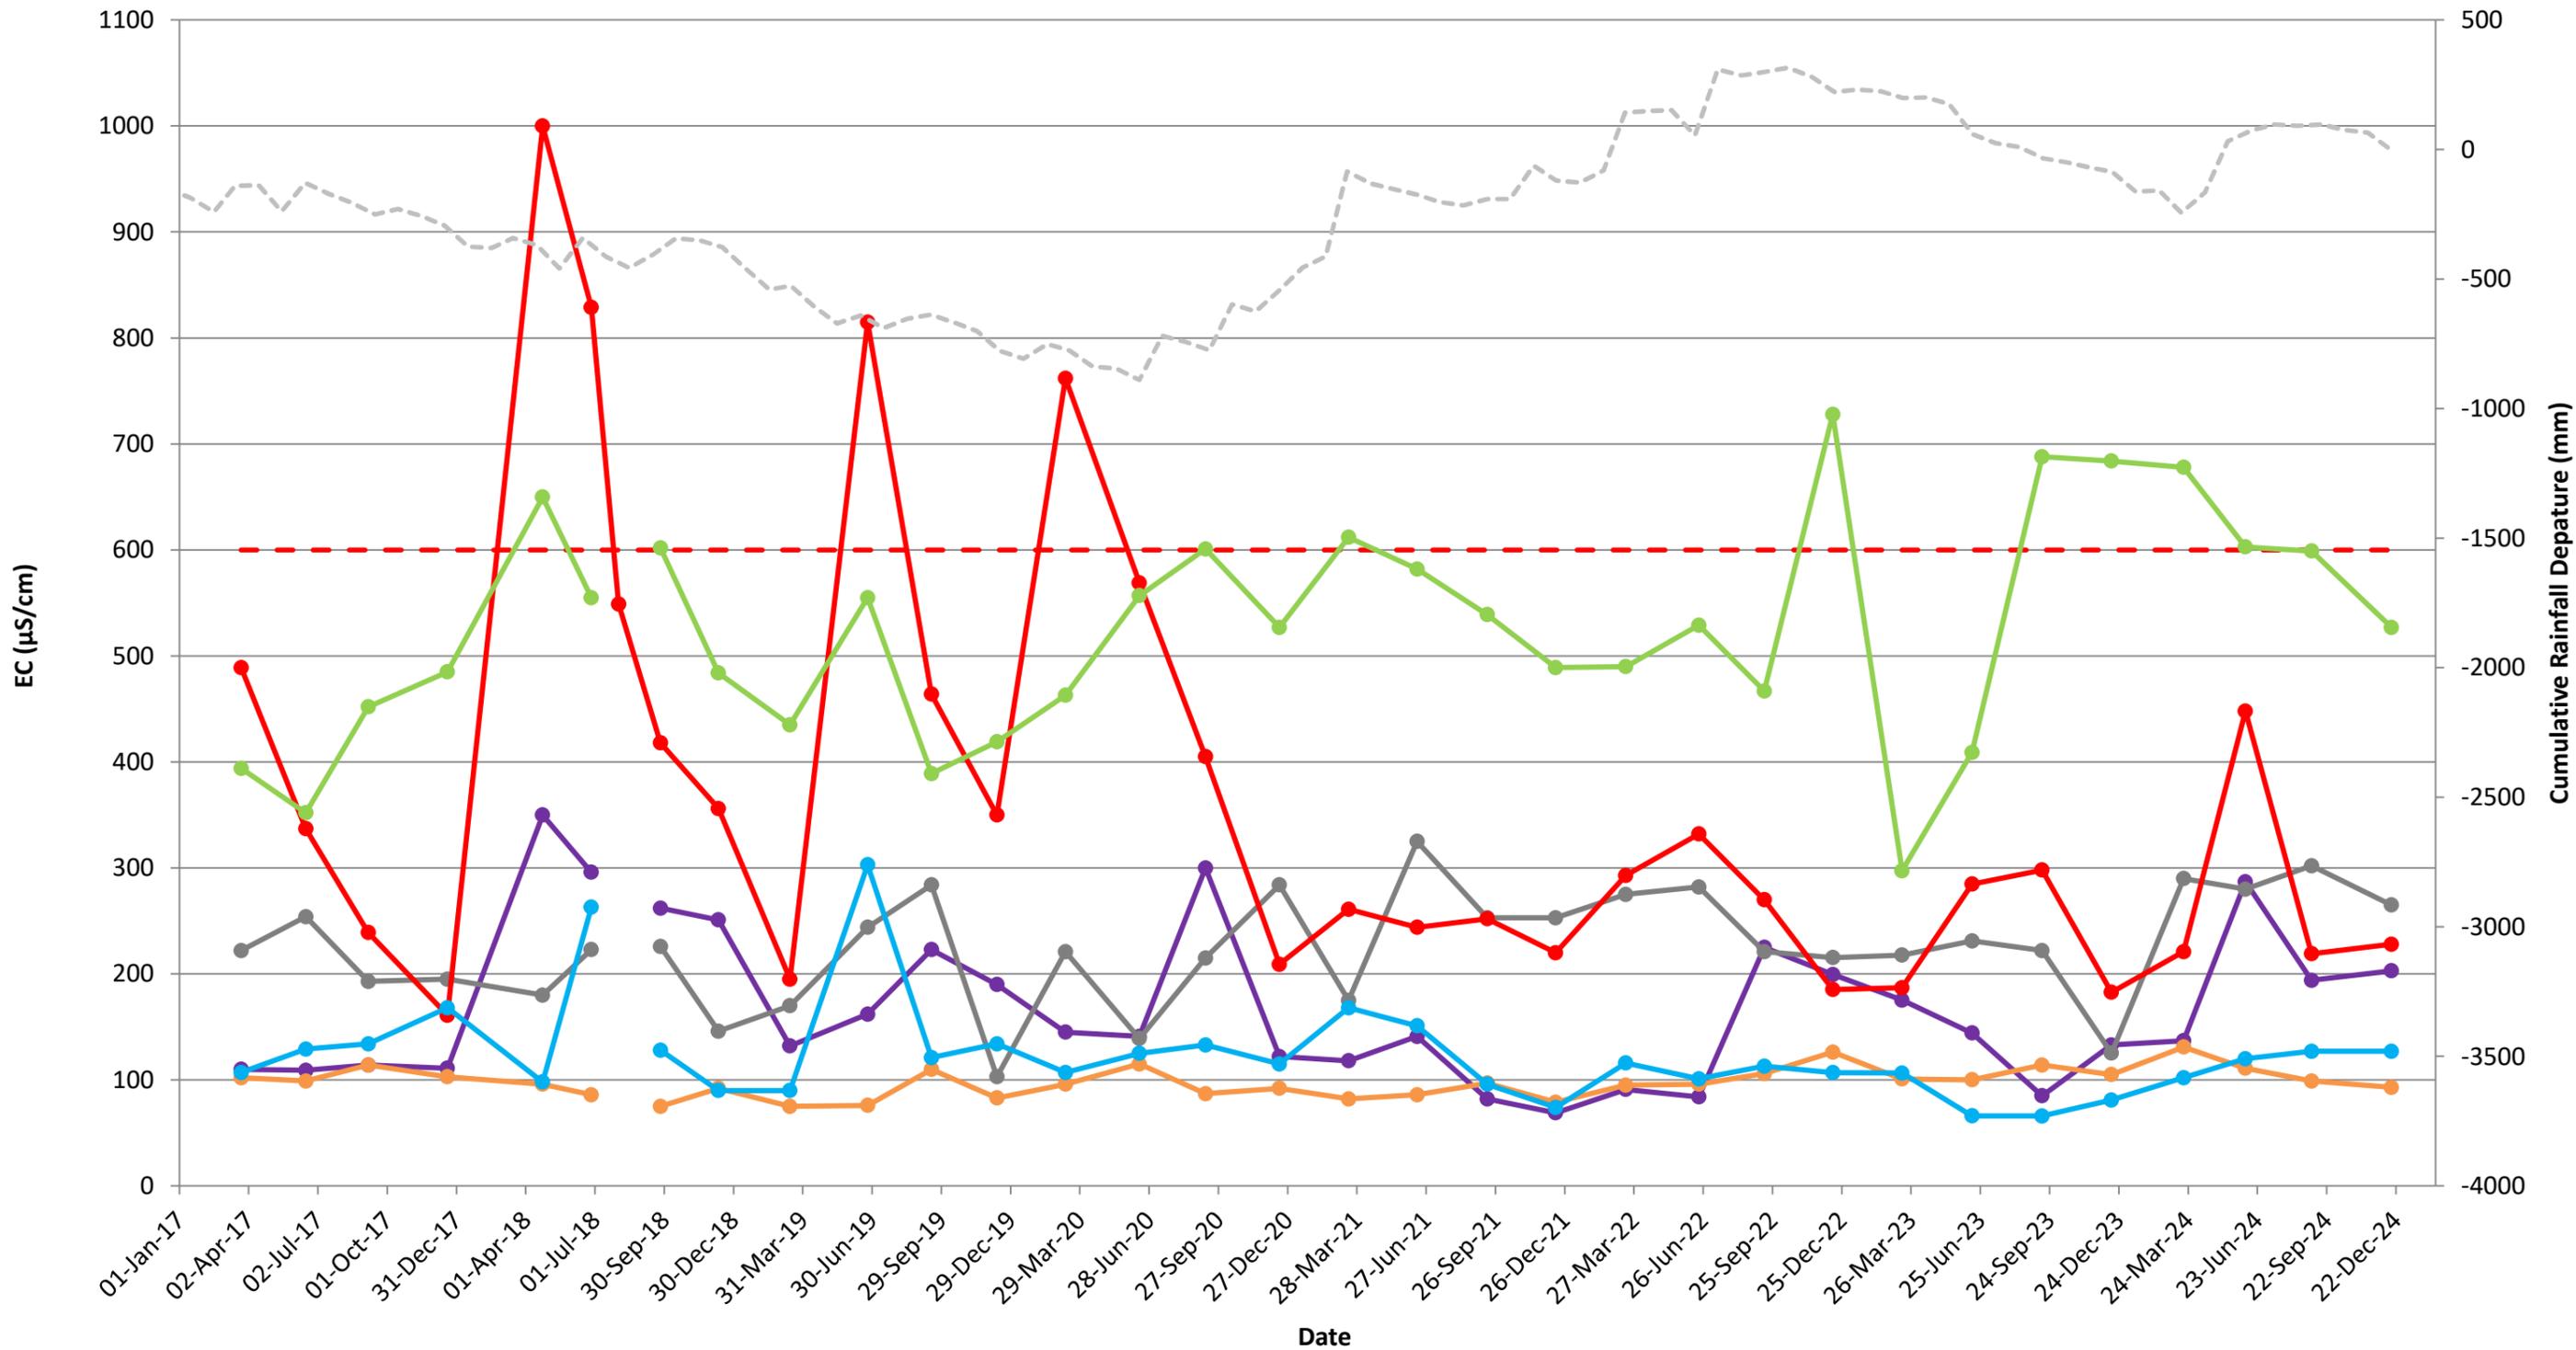
### Groundwater - Electrical Conductivity (EC)

Note: No EPL Limit Specified

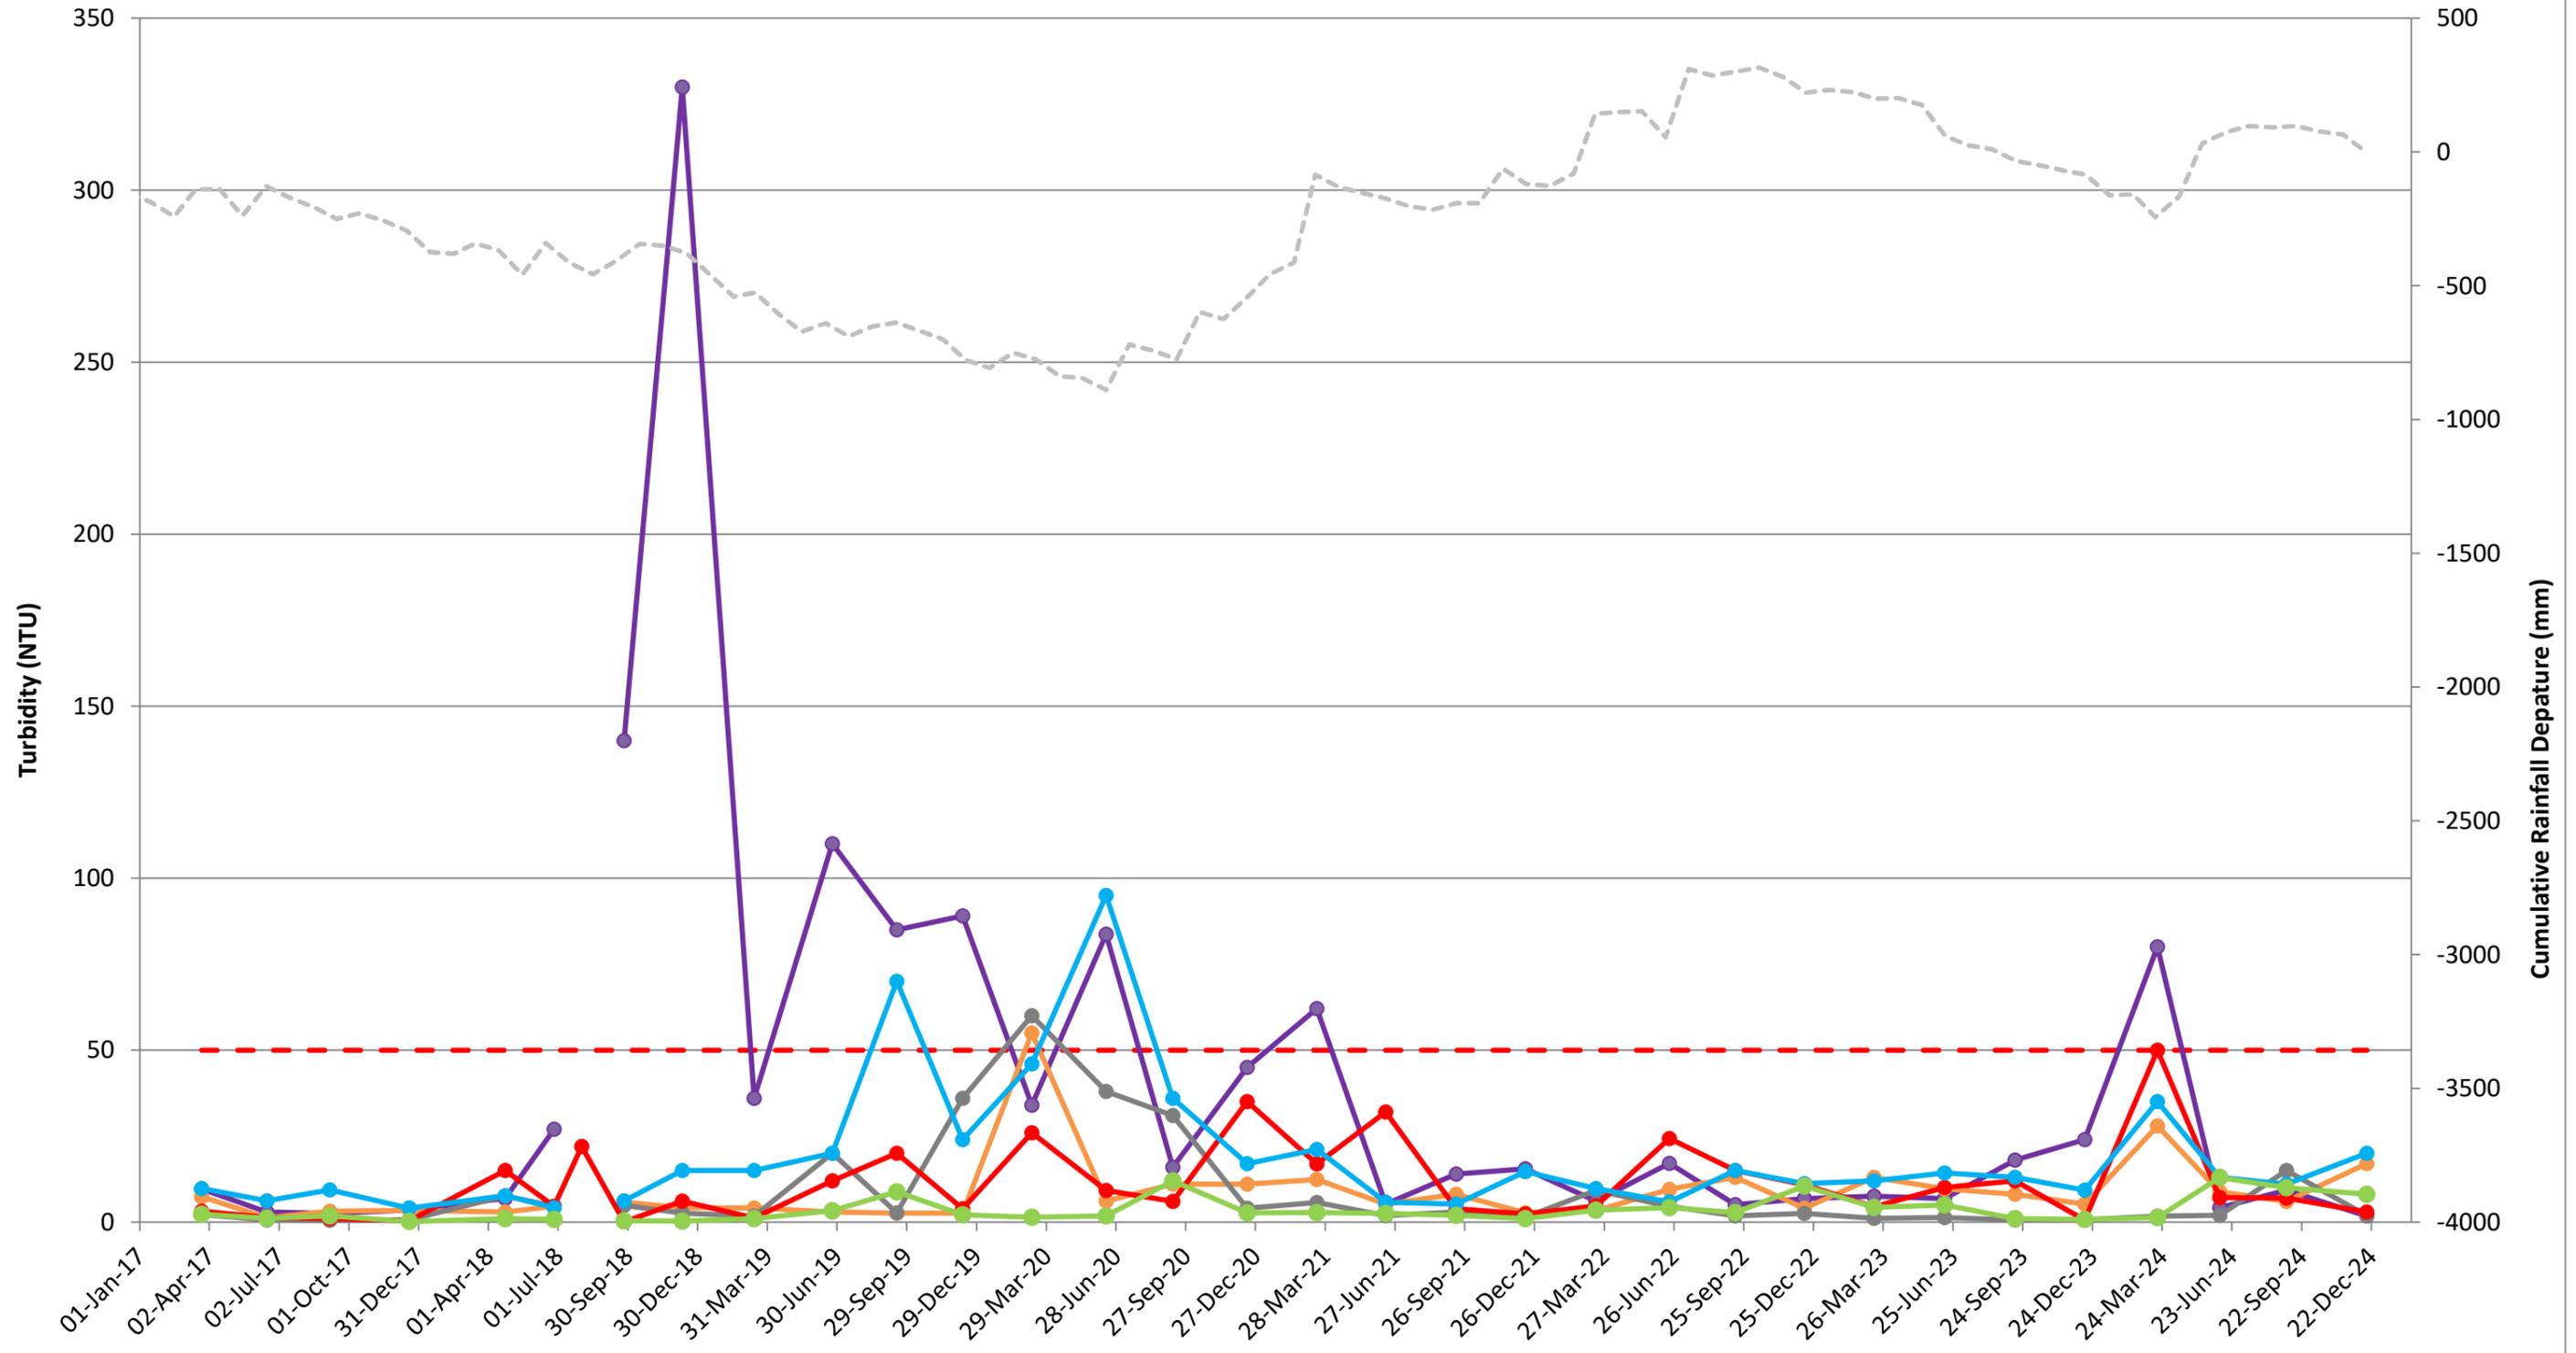
### Groundwater - Turbidity (NTU)

Note: No EPL Limit Specified

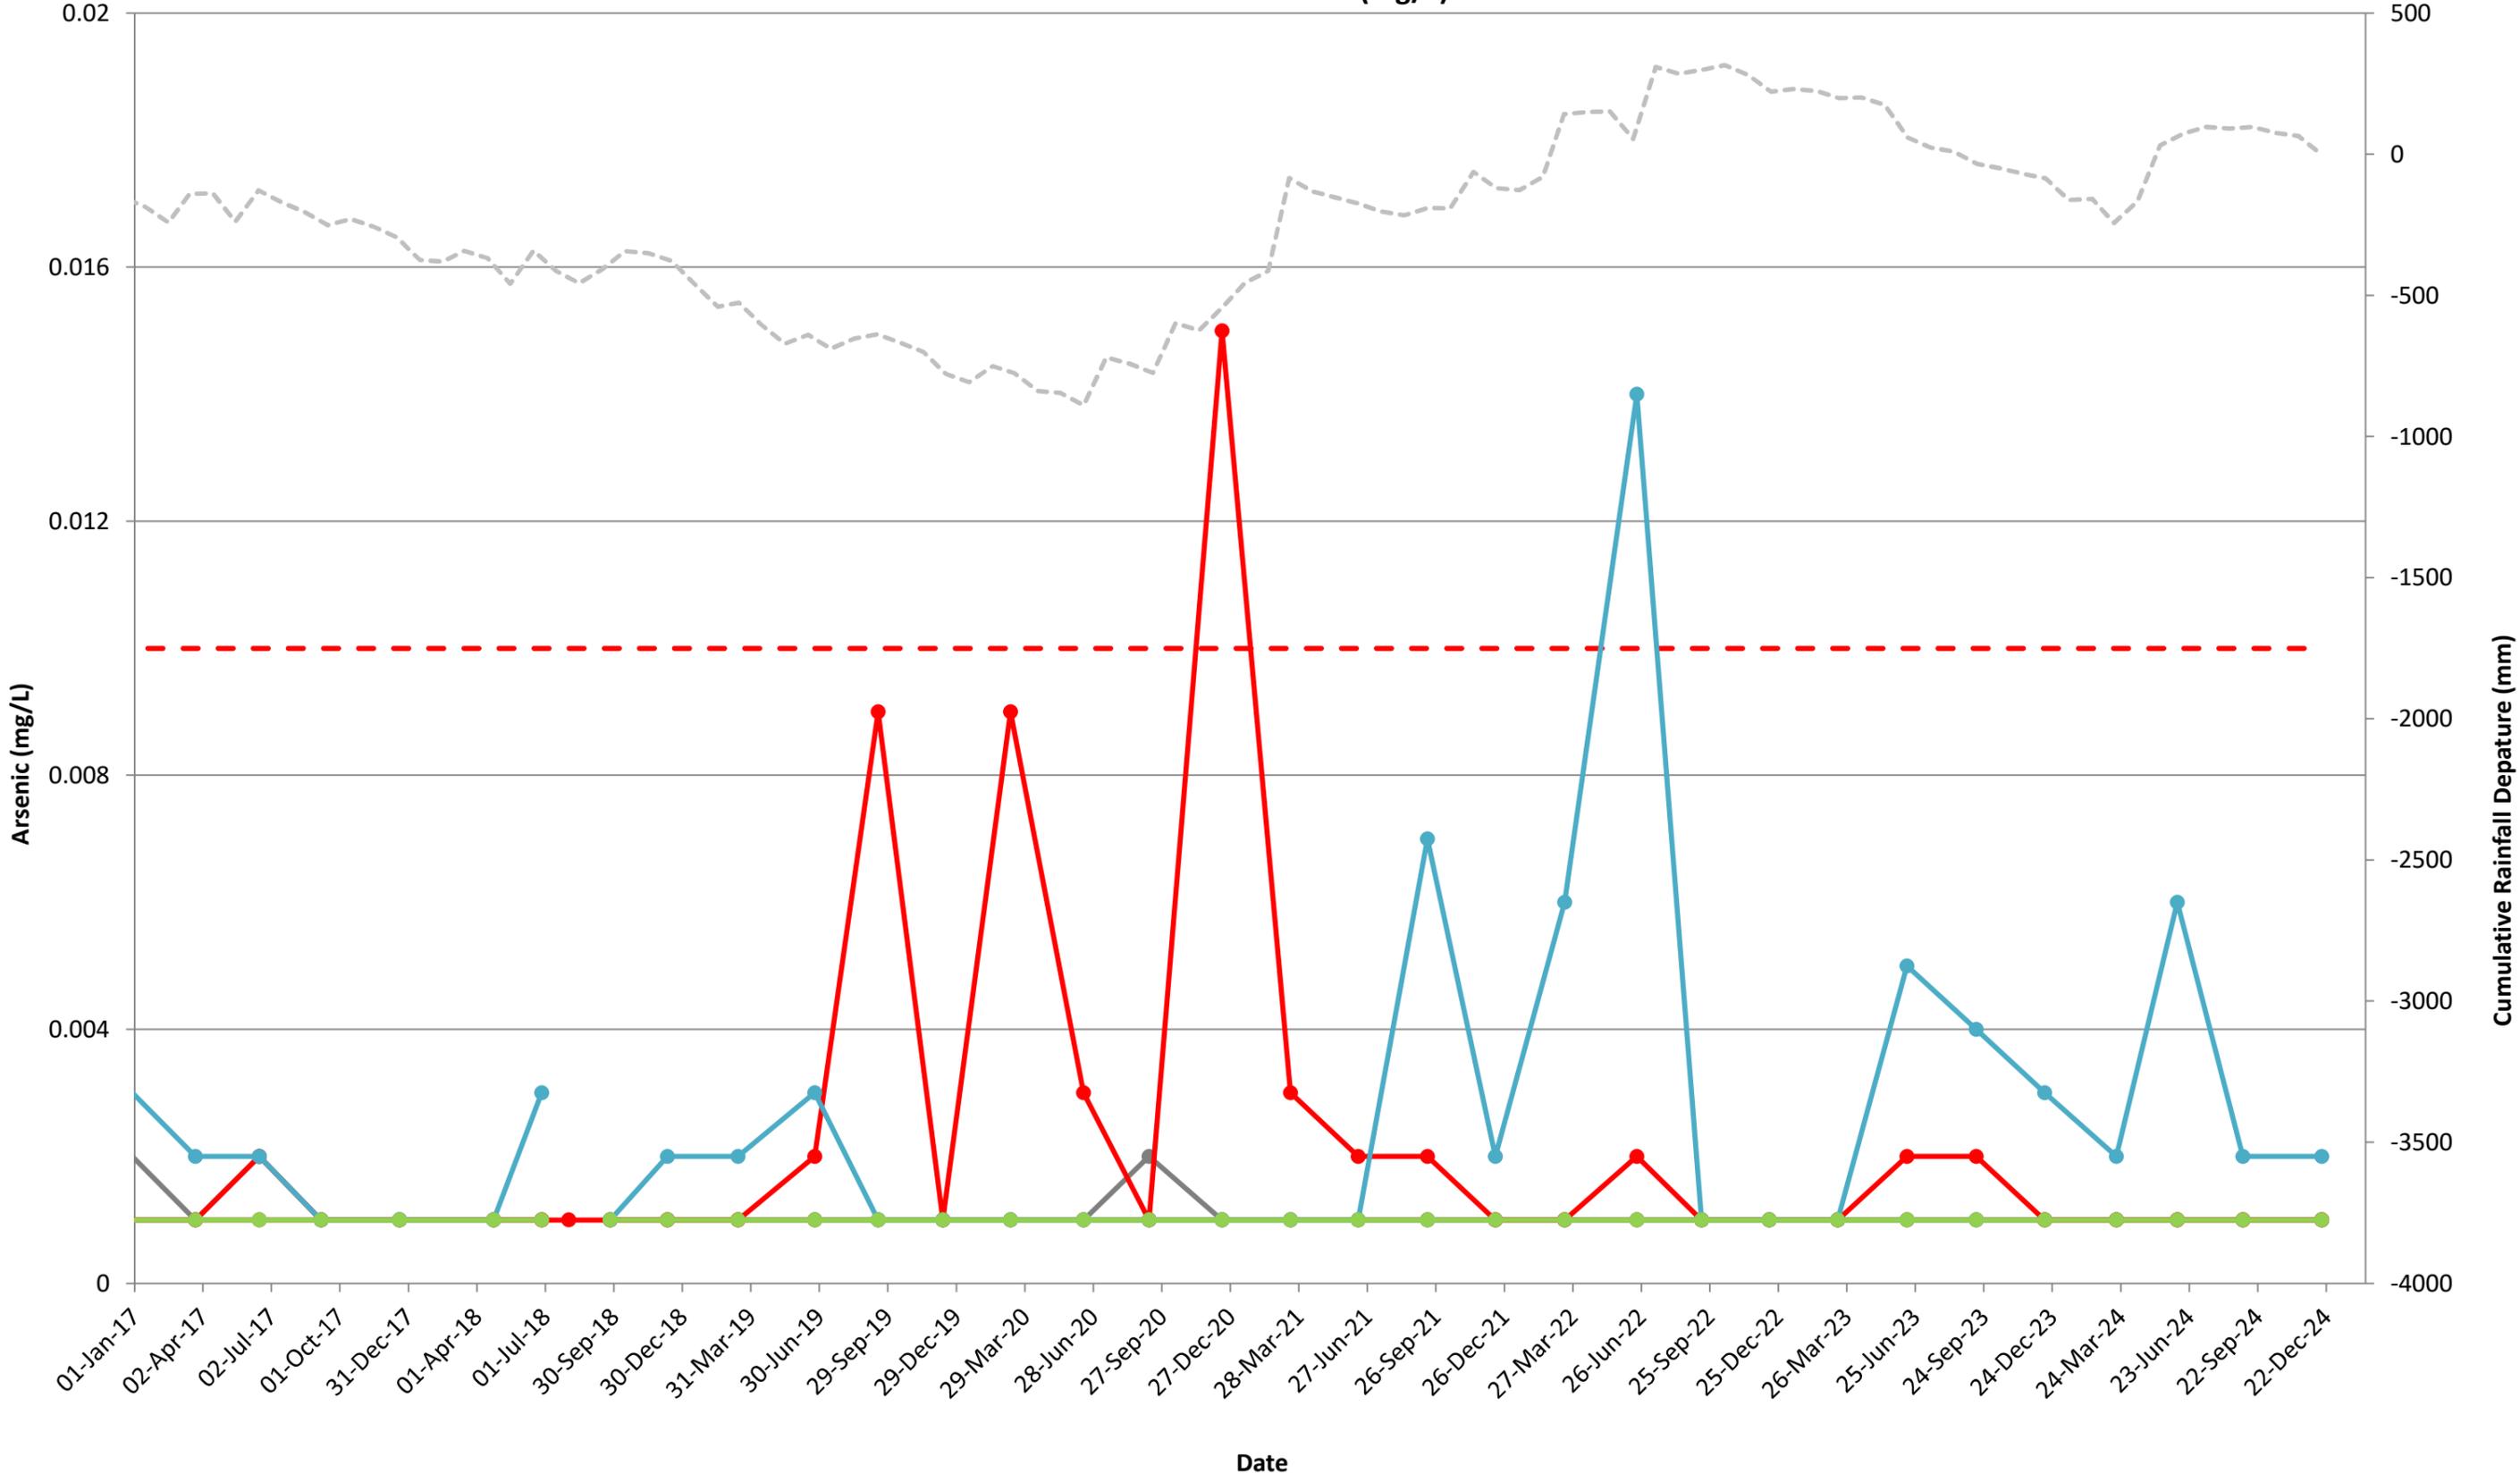
### Groundwater - Arsenic (mg/L)

Note: No EPL Limit Specified  
 Results reported as 0.001 mg/L are below  
 laboratory Limit of Reporting (LoR)

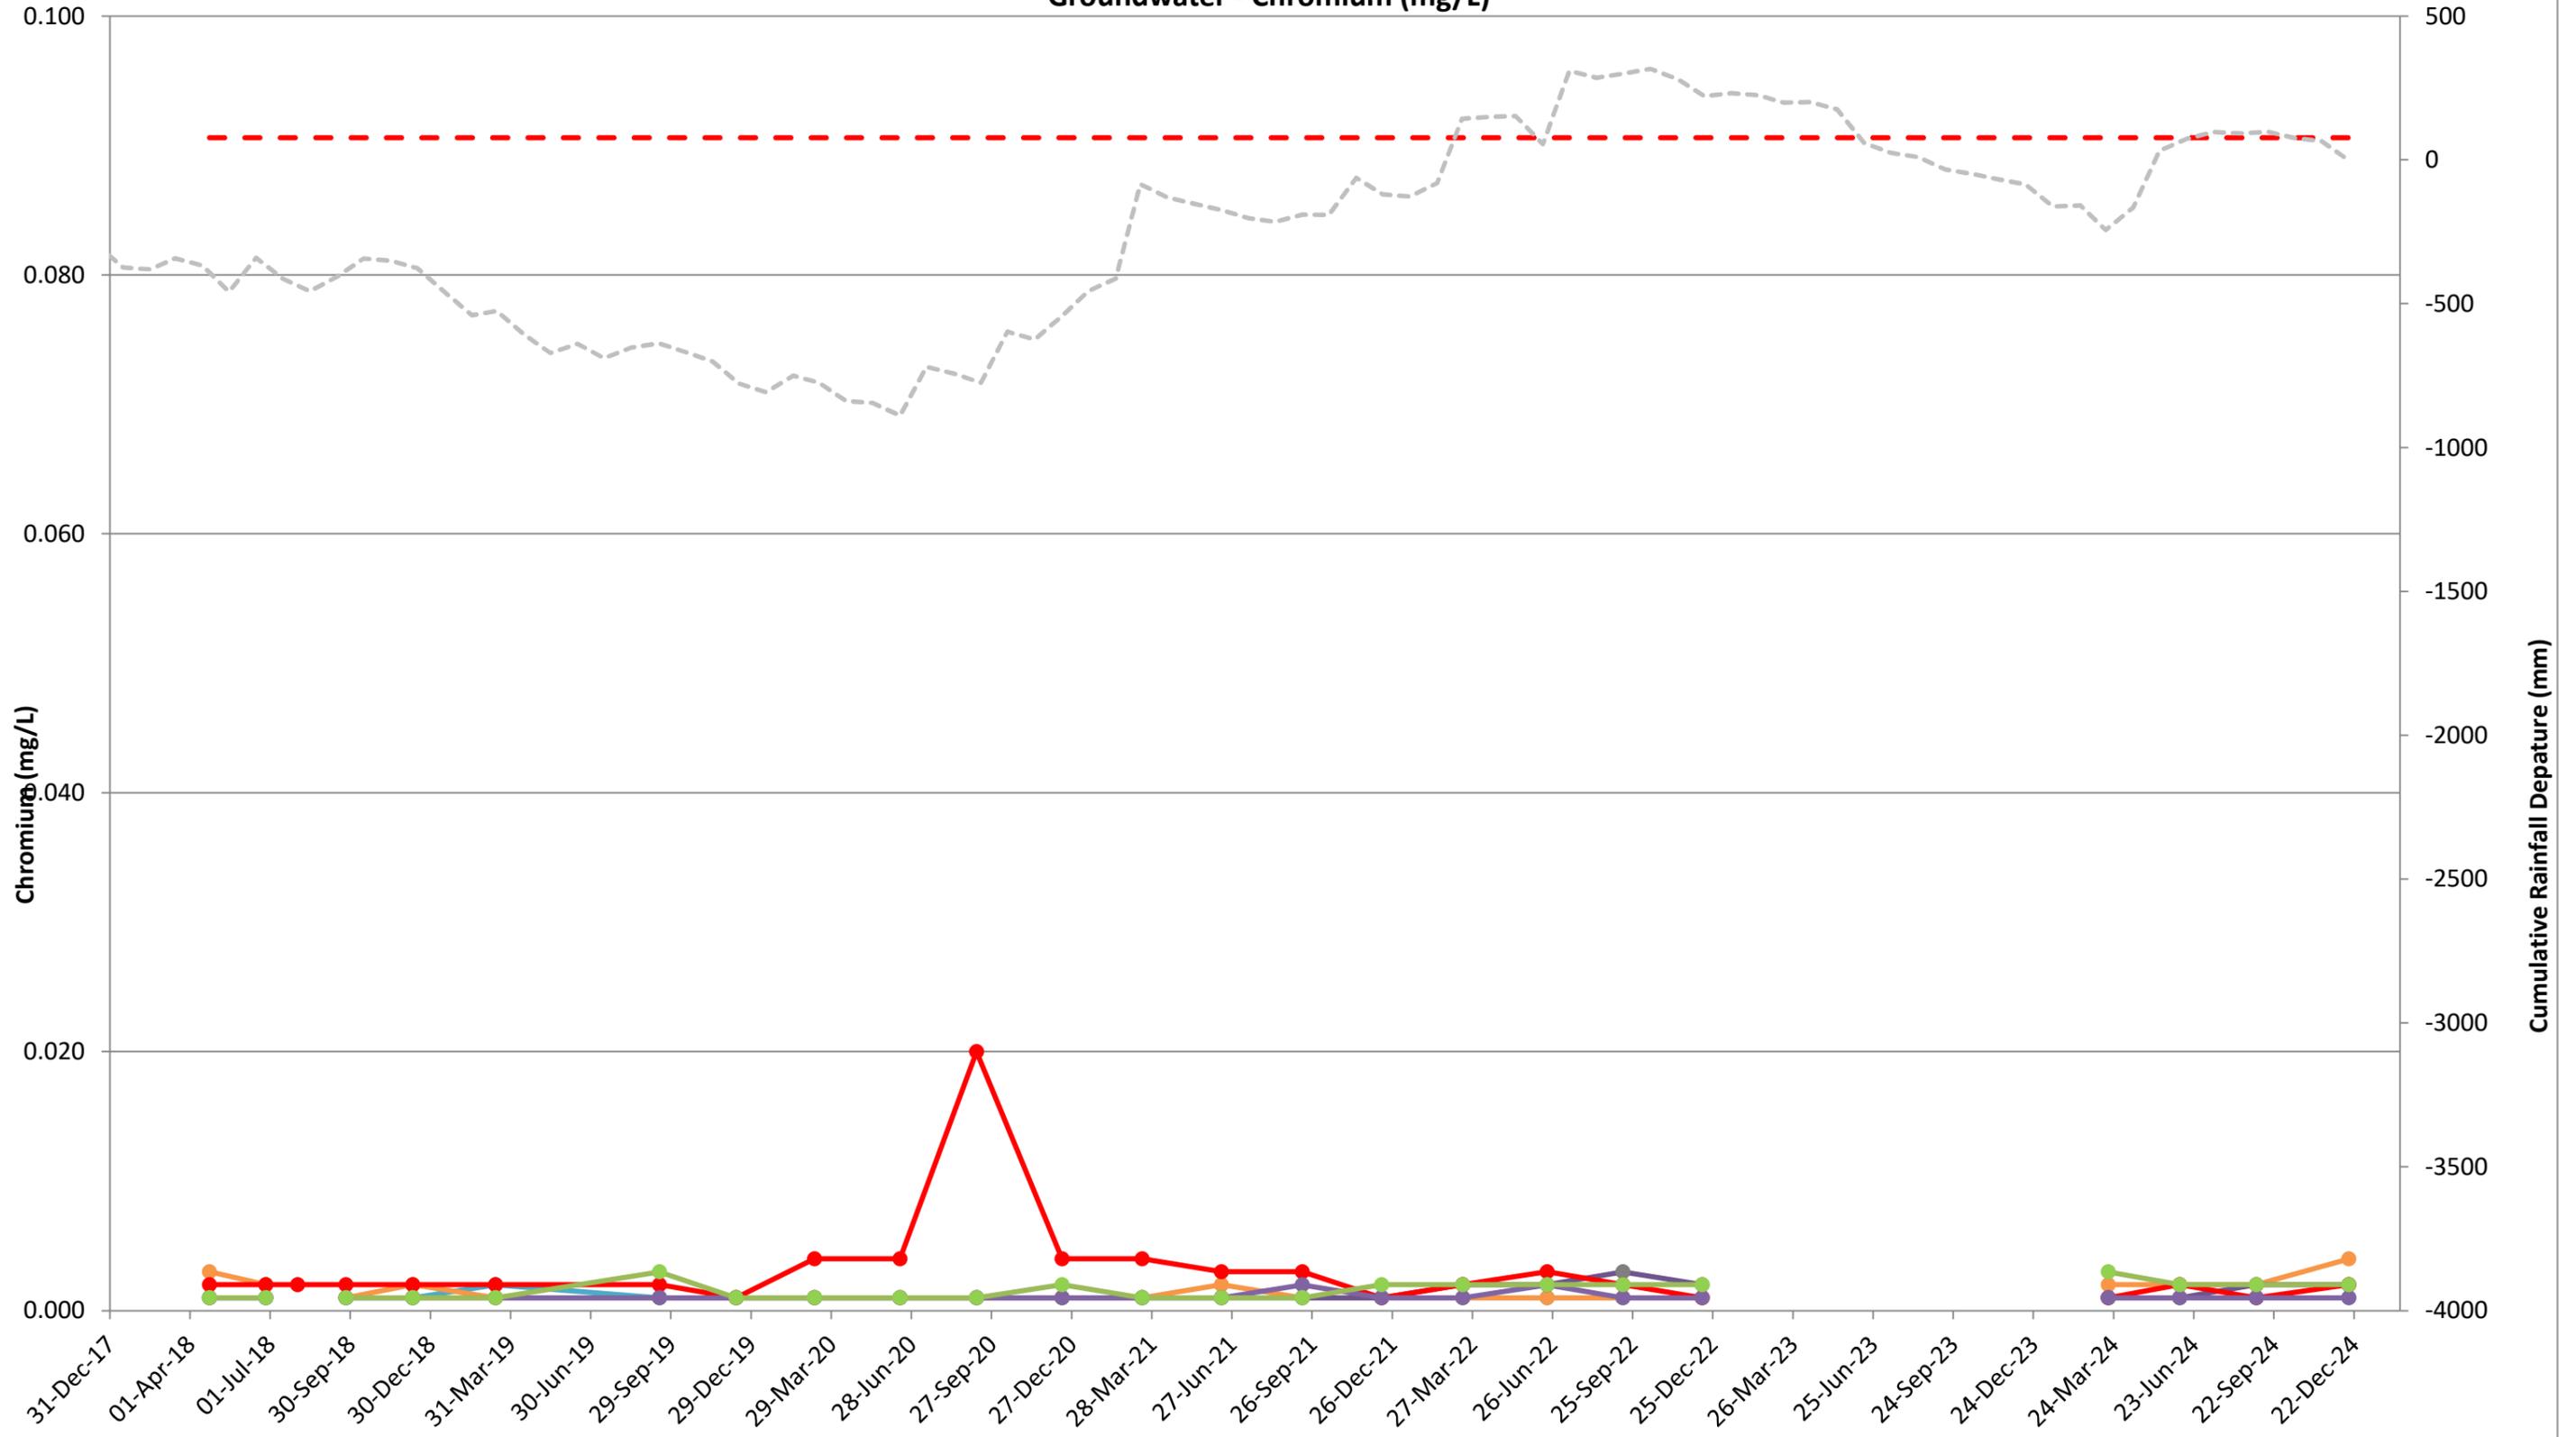
### Groundwater - Chromium (mg/L)

Note: No EPL Limit Specified  
 Results reported as 0.001 mg/L are below laboratory Limit of Reporting (LoR)
