## MACKAS SAND ANNUAL REVIEW 2024

January–December 2024

March 2025

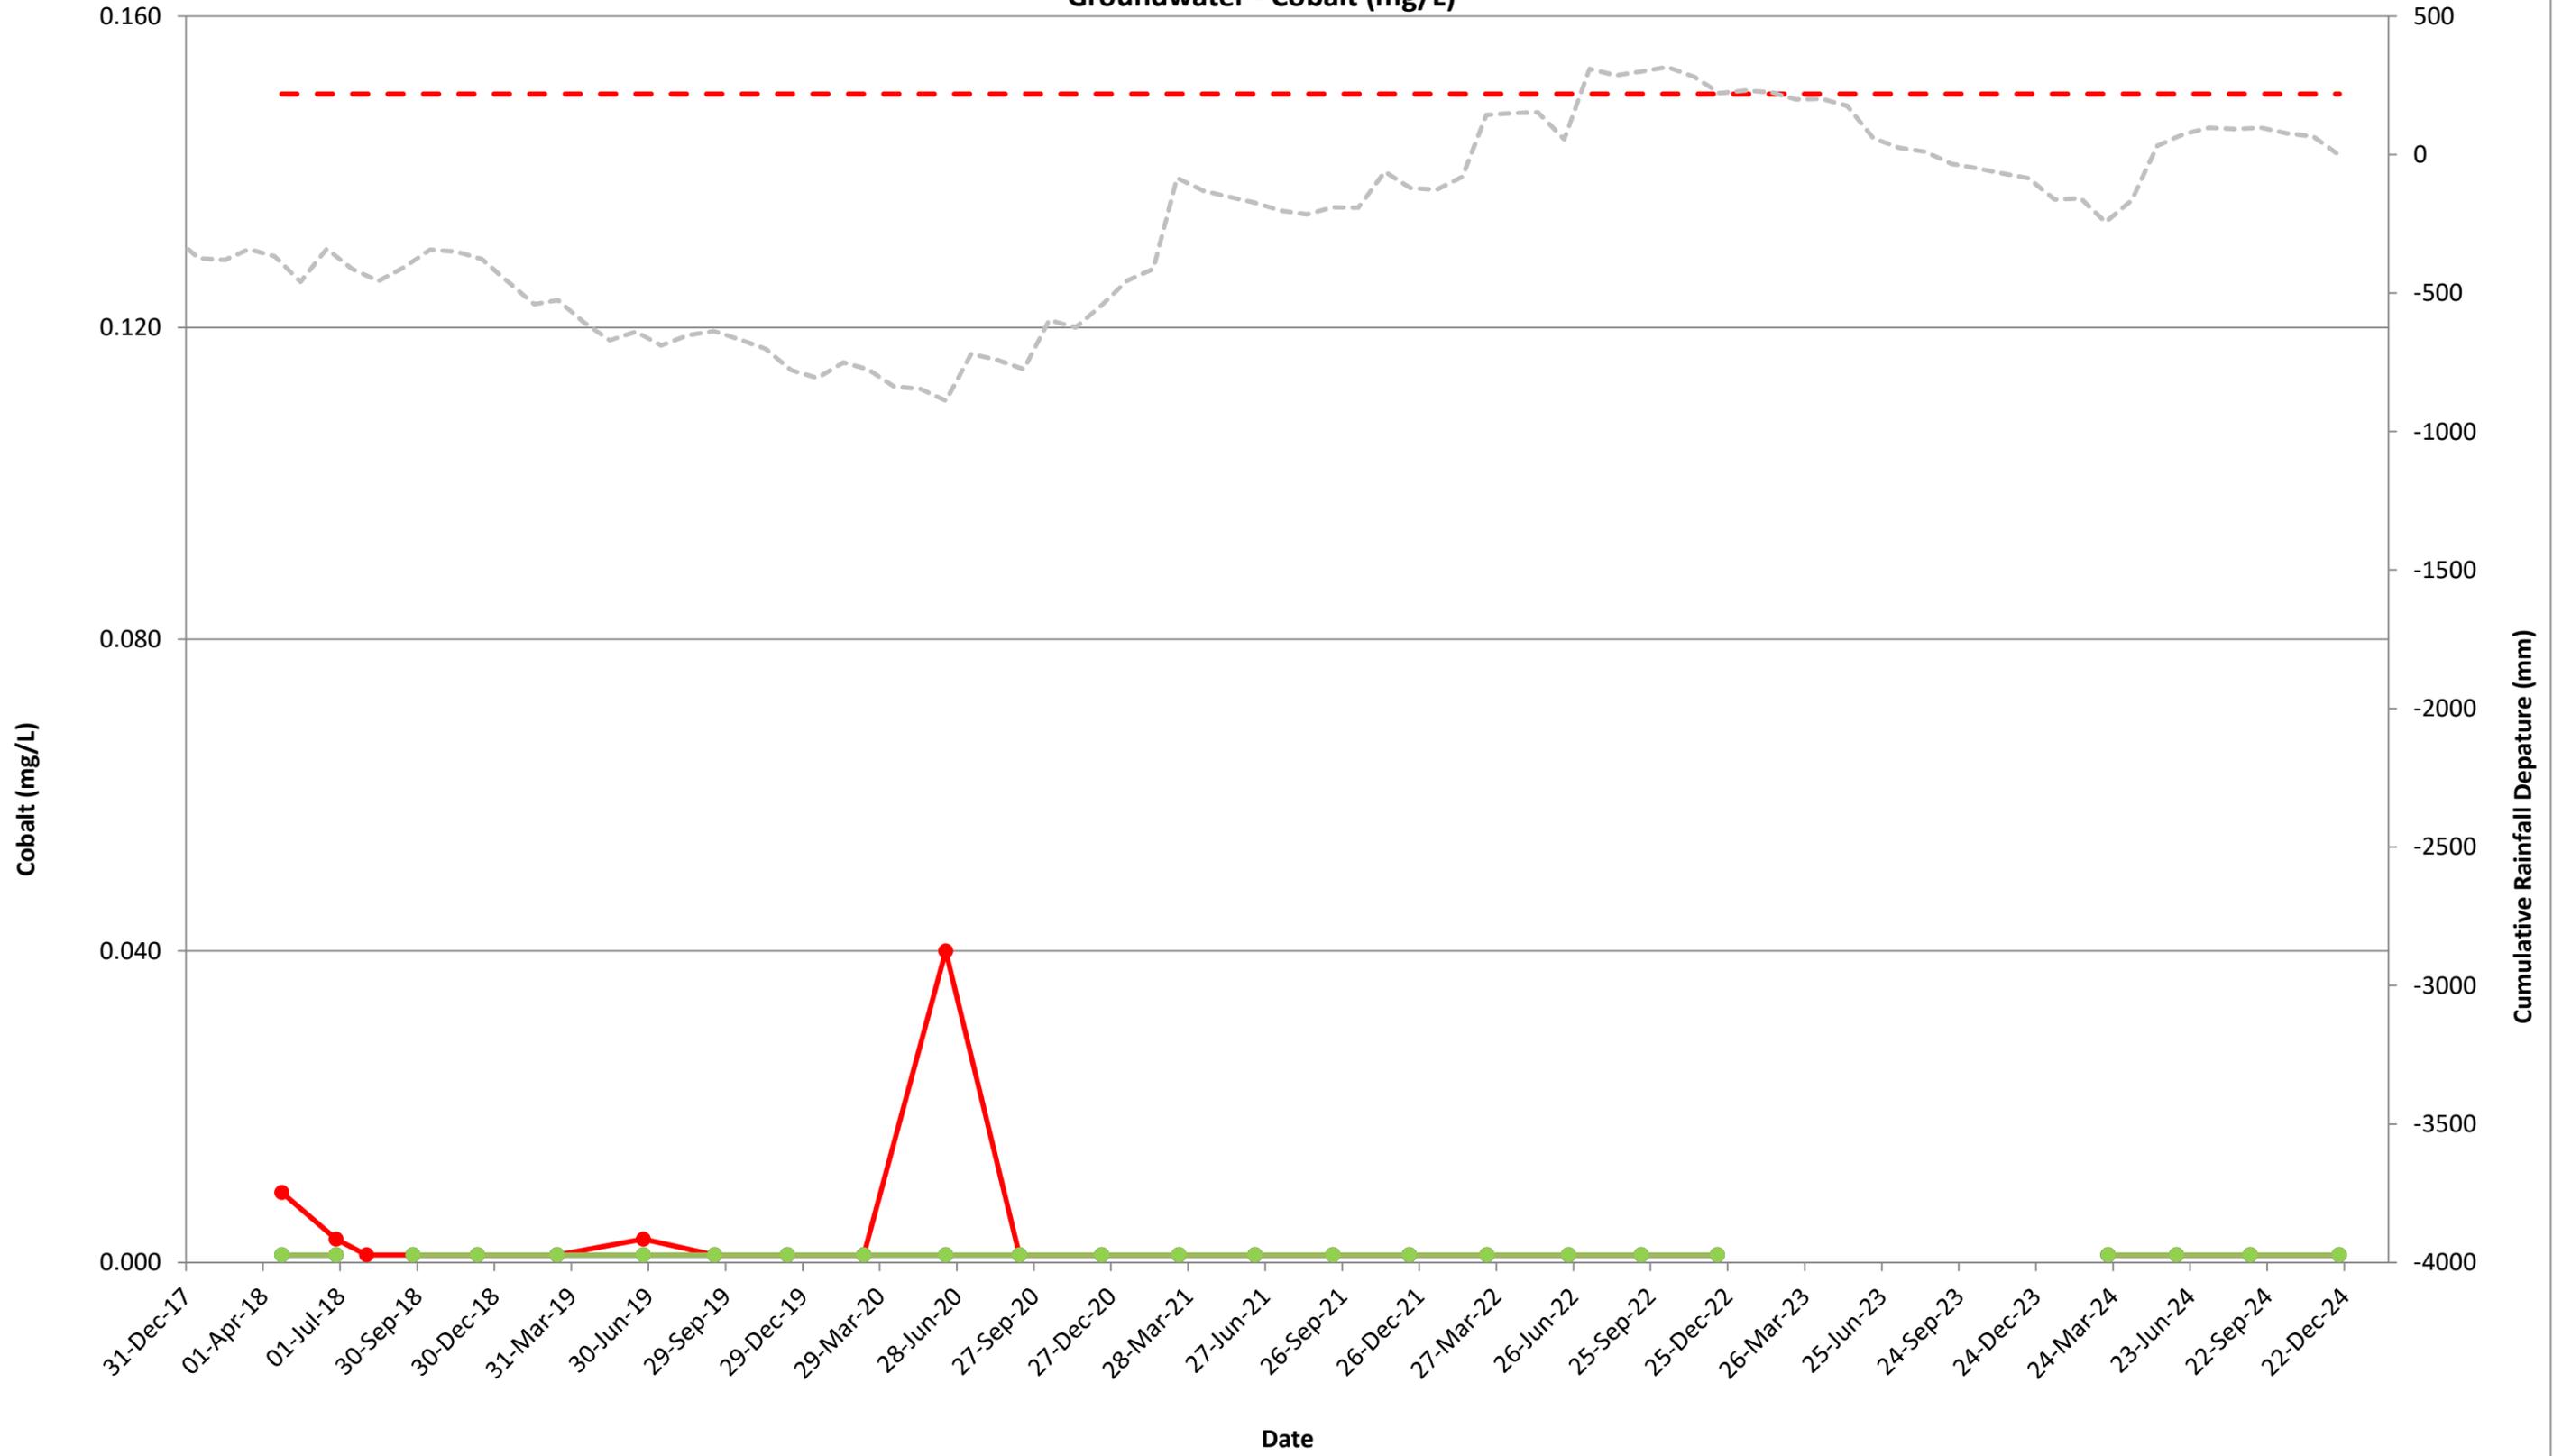
### Groundwater - Cobalt (mg/L)

Note: No EPL Limit Specified  
 Results reported as 0.001 mg/L are below laboratory Limit of Reporting (LoR)

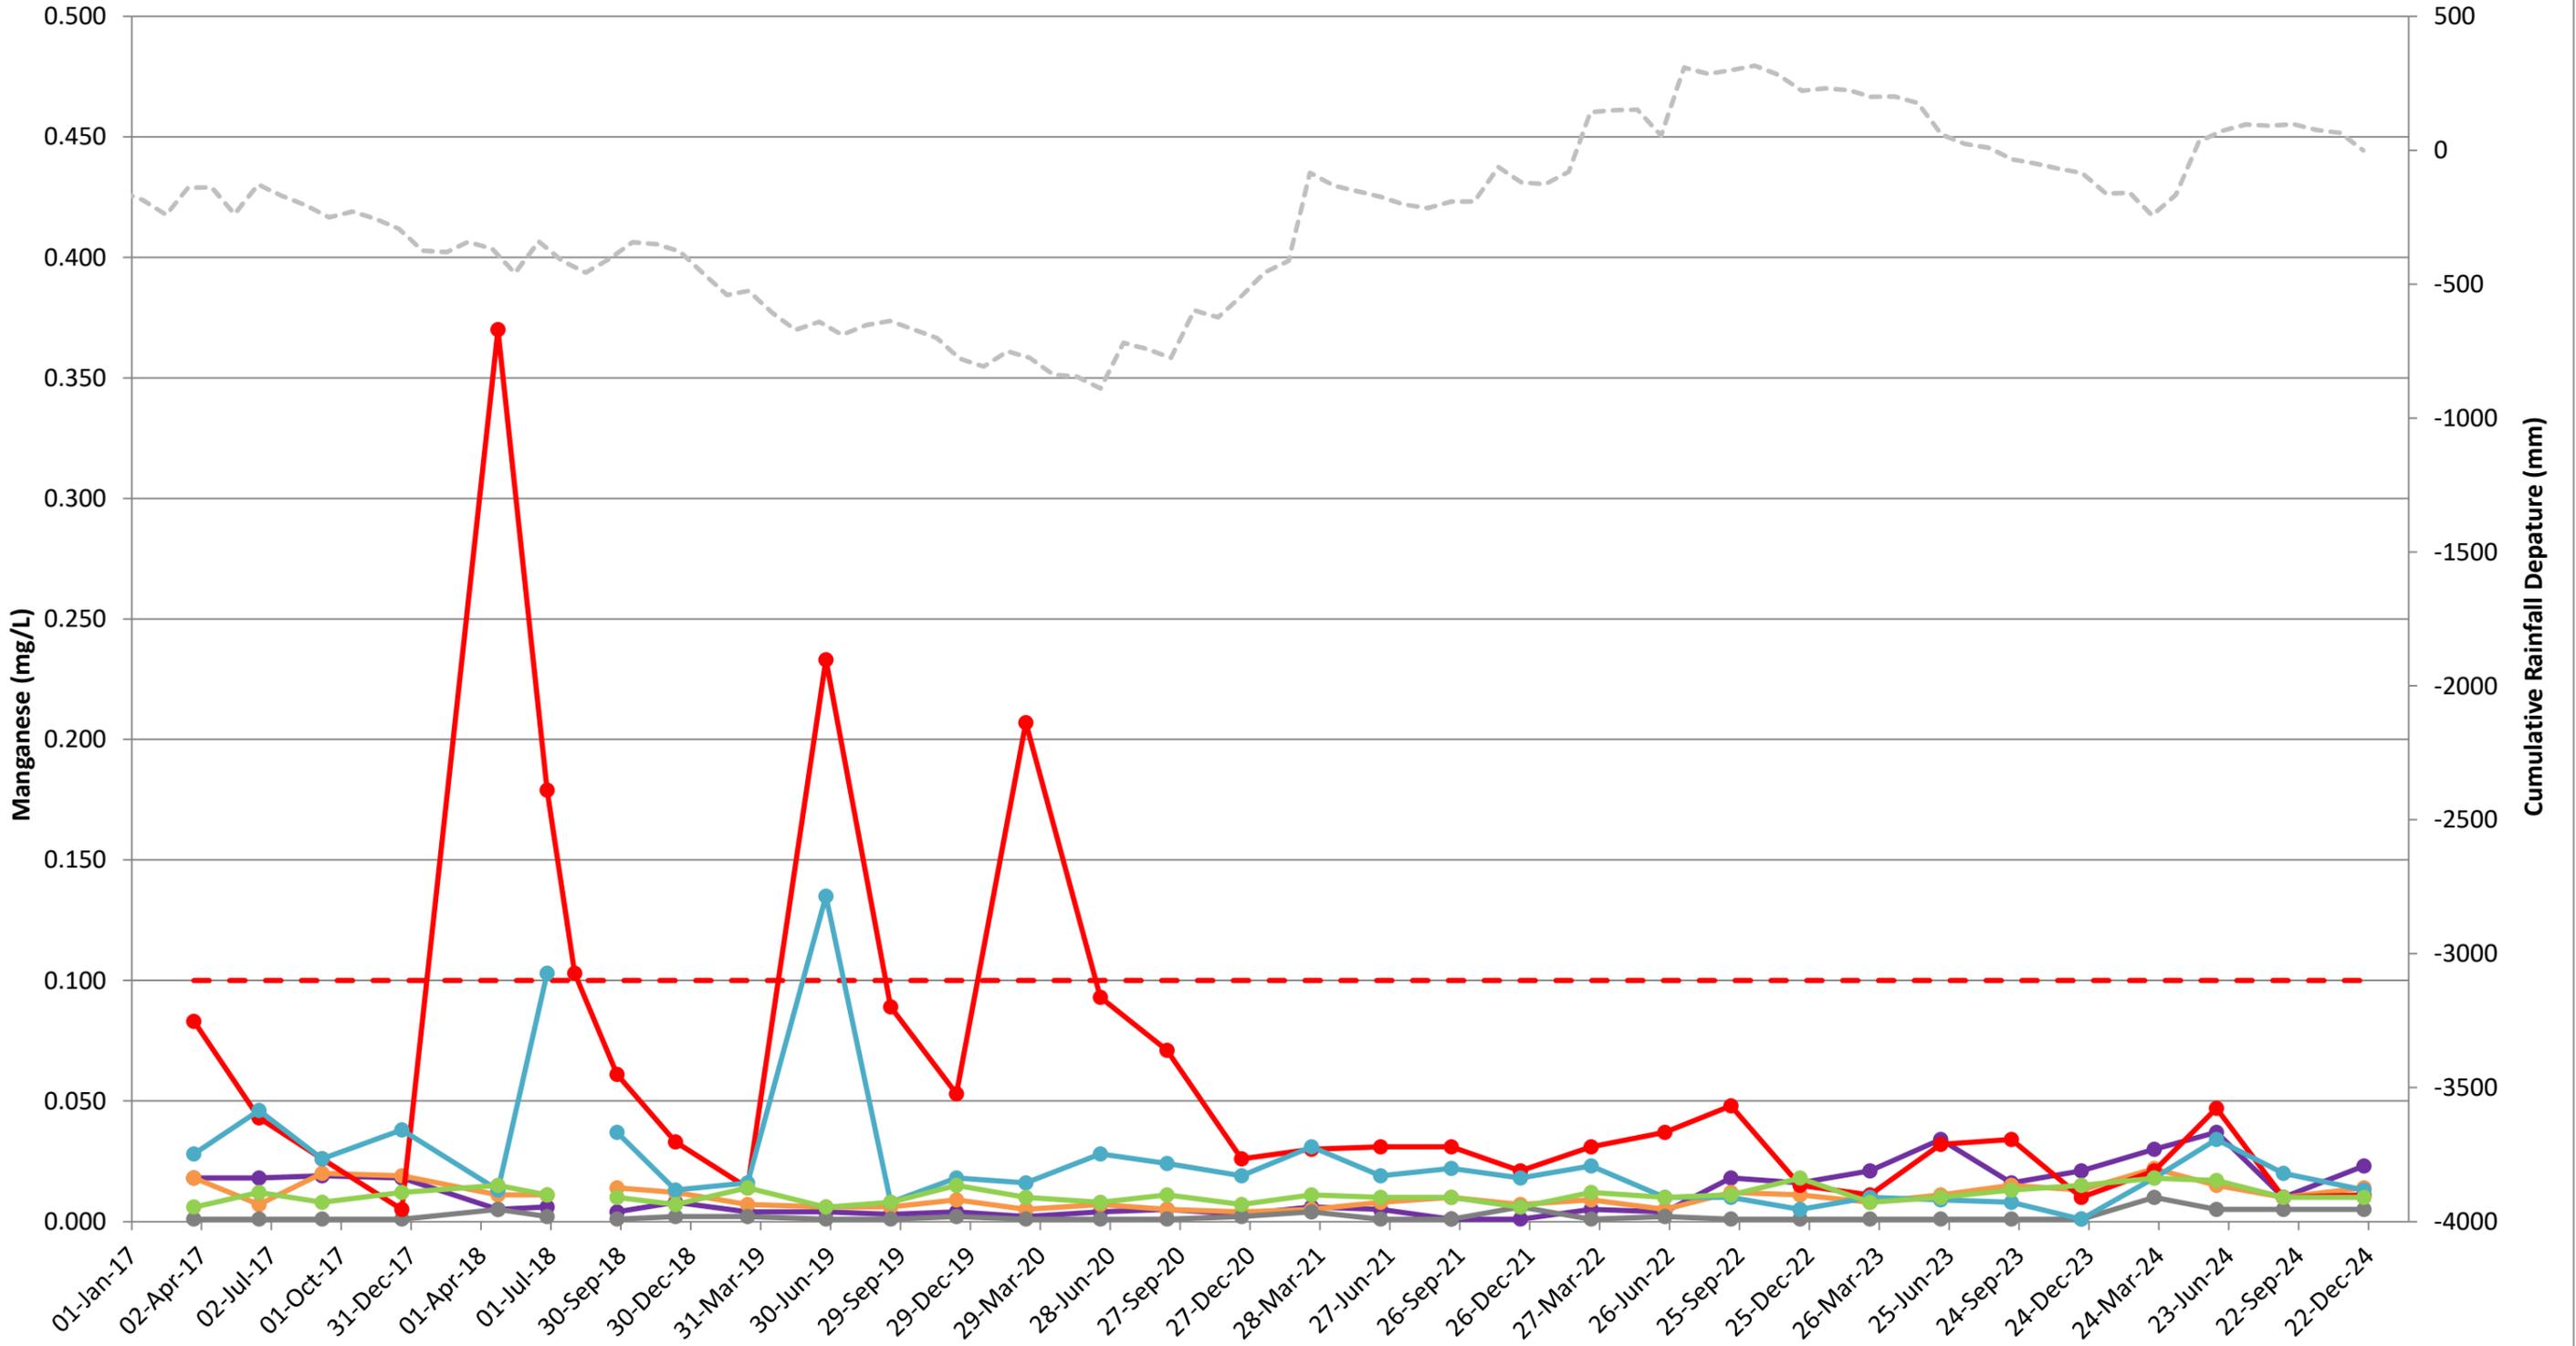
### Groundwater - Manganese (mg/L)

Note: No EPL Limit Specified  
 Results reported as 0.001 mg/L are below laboratory  
 Limit of Reporting (LoR)

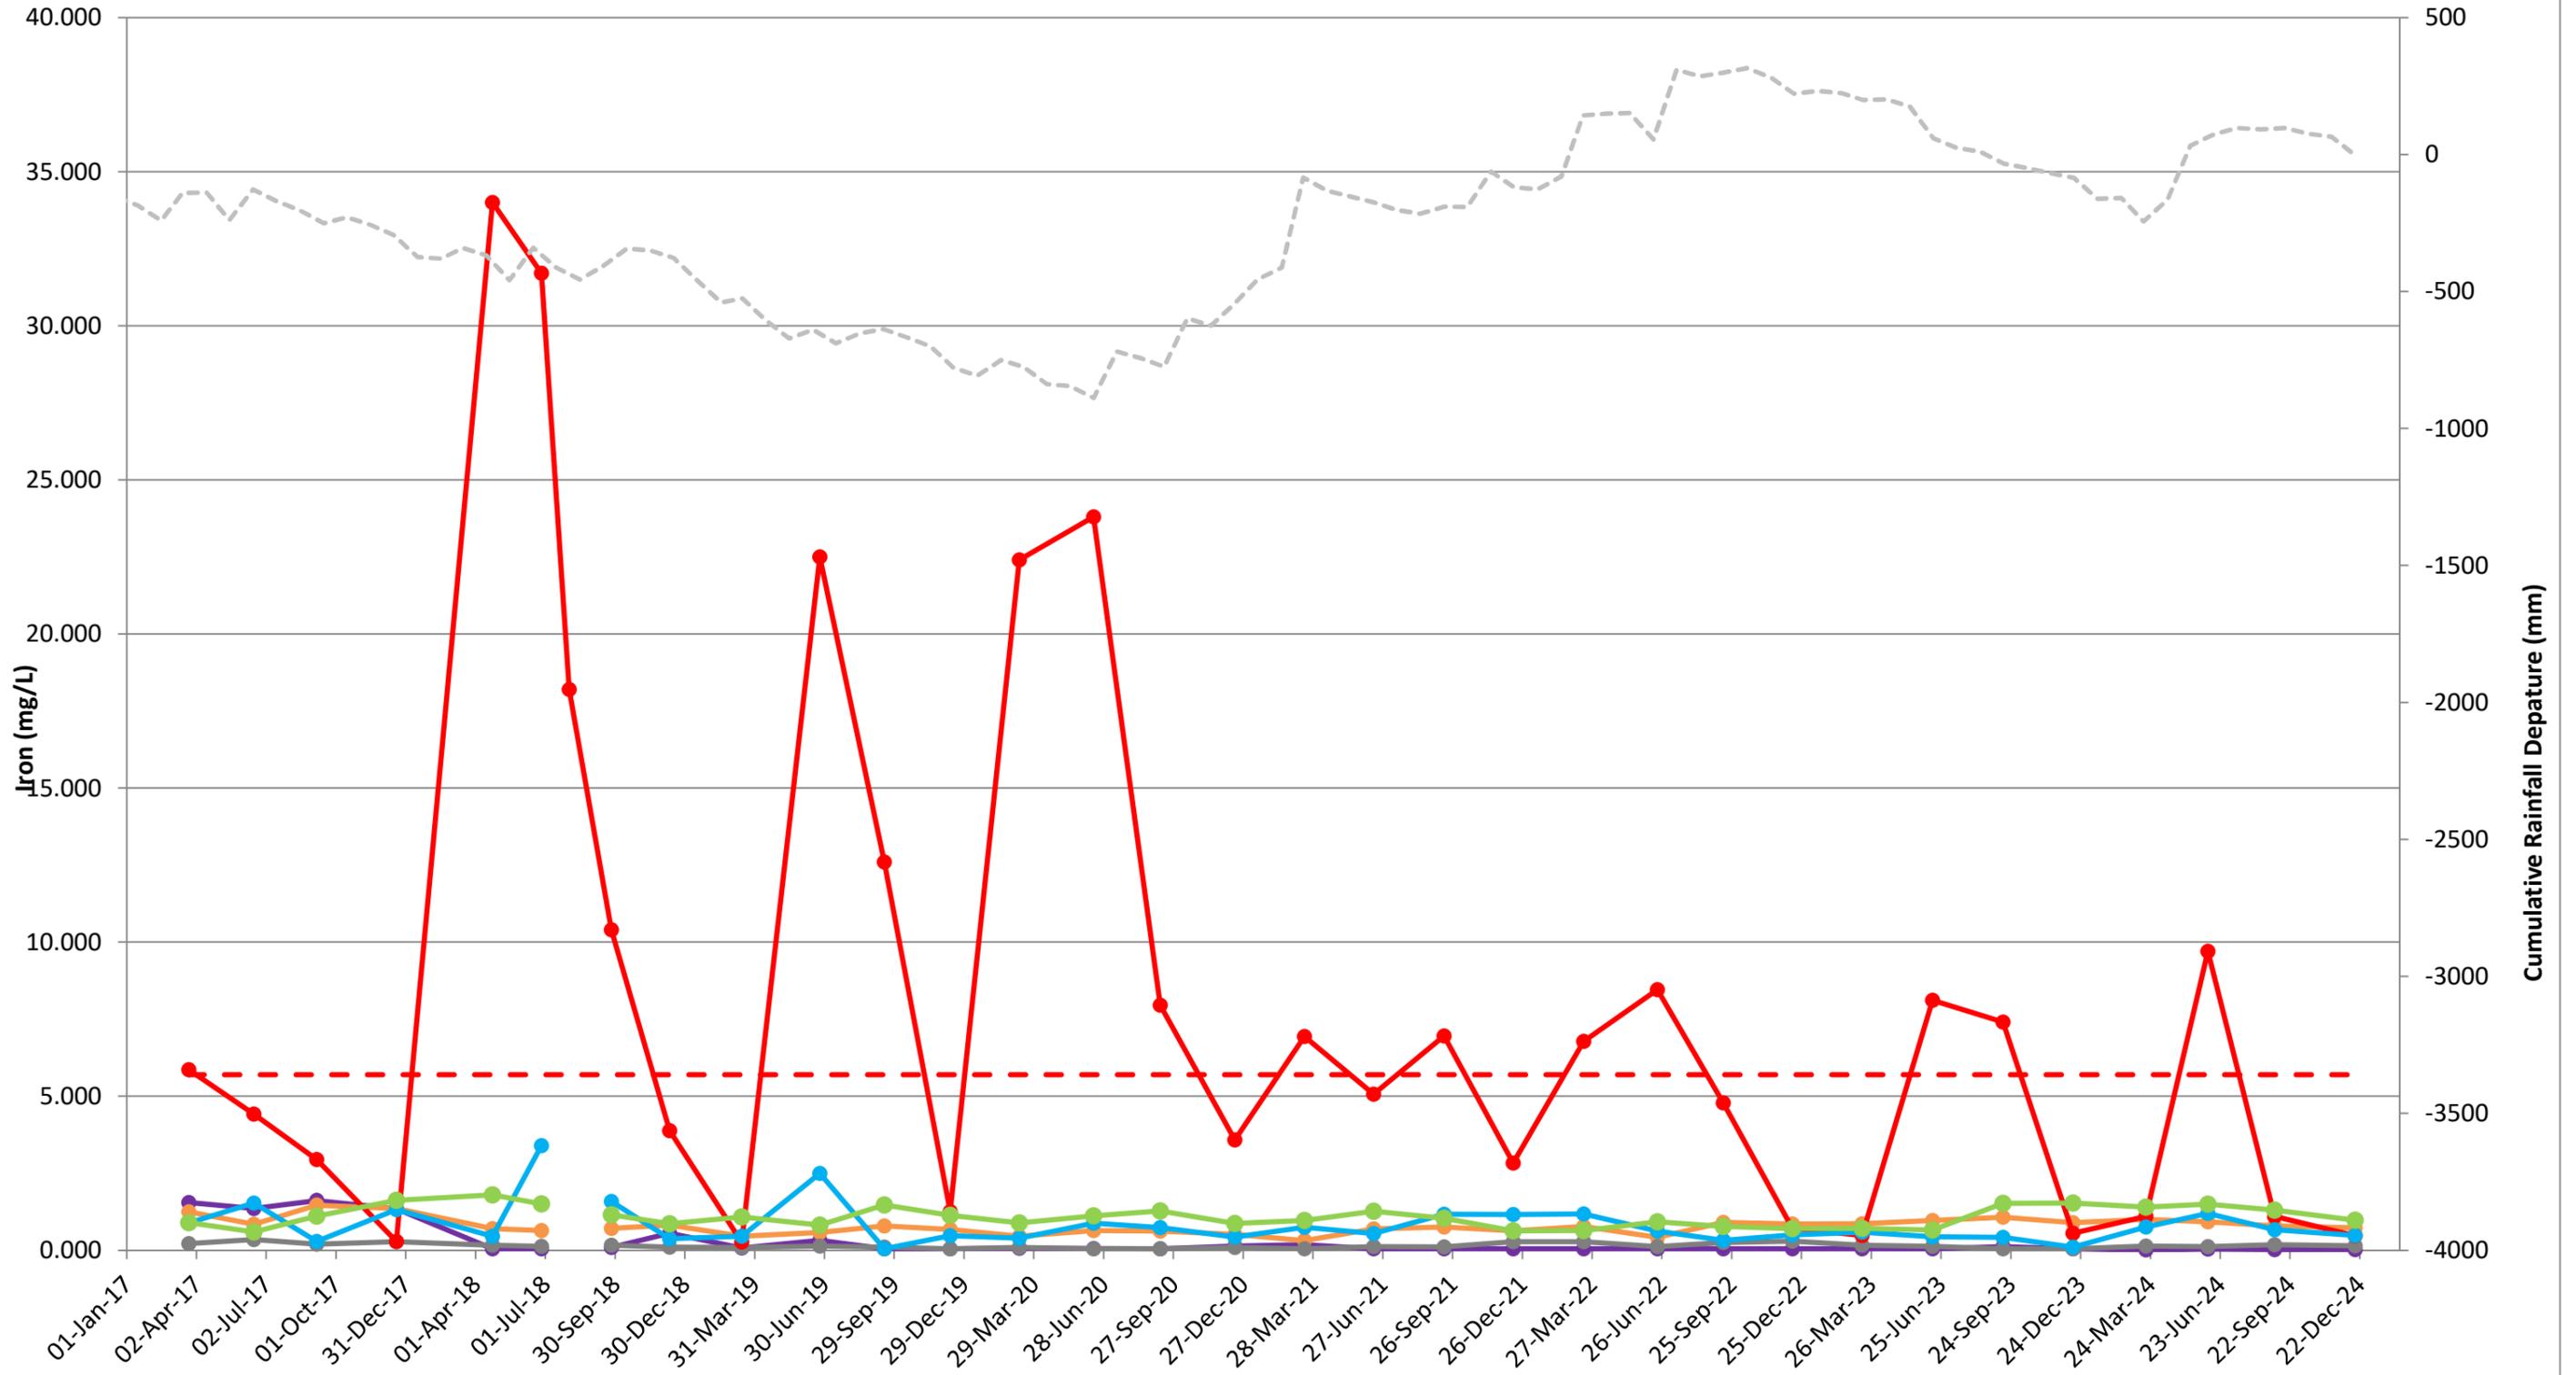
### Groundwater - Iron (mg/L)

Note: No EPL Limit Specified  
 Results reported as 0.001 mg/L are below  
 laboratory Limit of Reporting (LoR)
