# **MACKAS SAND ANNUAL REVIEW 2025**

January to December 2025

<b>Name of operation</b>	Mackas Sand Project
<b>Name of operator</b>	Mackas Sand Pty Limited
<b>Development Consent / Project Approval No.</b>	PA 08_0142 (MOD 2)
<b>Name of holder of development consent/project approval</b>	Mackas Sand Pty Limited
<b>Mining lease No.</b>	No Mining Lease applicable to site under the Mining Act (1992).
<b>Name of holder of mining lease</b>	N/A
<b>Water licence #</b>	N/A
<b>Name of holder of water licence</b>	N/A
<b>MOP/RMP start date</b>	N/A
<b>MOP/RMP end date</b>	N/A
<b>Annual Review start date</b>	1 January 2025
<b>Annual Review end date</b>	31 December 2025
<p>I, Robert Mackenzie, certify that this audit report is a true and accurate record of the compliance status of Macka's Sand Pty Ltd for the period 1 January 2025 to 31 December 2025 and that I am authorised to make this statement on behalf of Macka's Sand Pty Ltd.</p> <p>Note: The Annual Review is an 'environmental audit' for the purposes of section 122B (2) of the Environmental Planning and Assessment Act 1979. Section 122E provides that a person must not include false or misleading information (or provide information for inclu

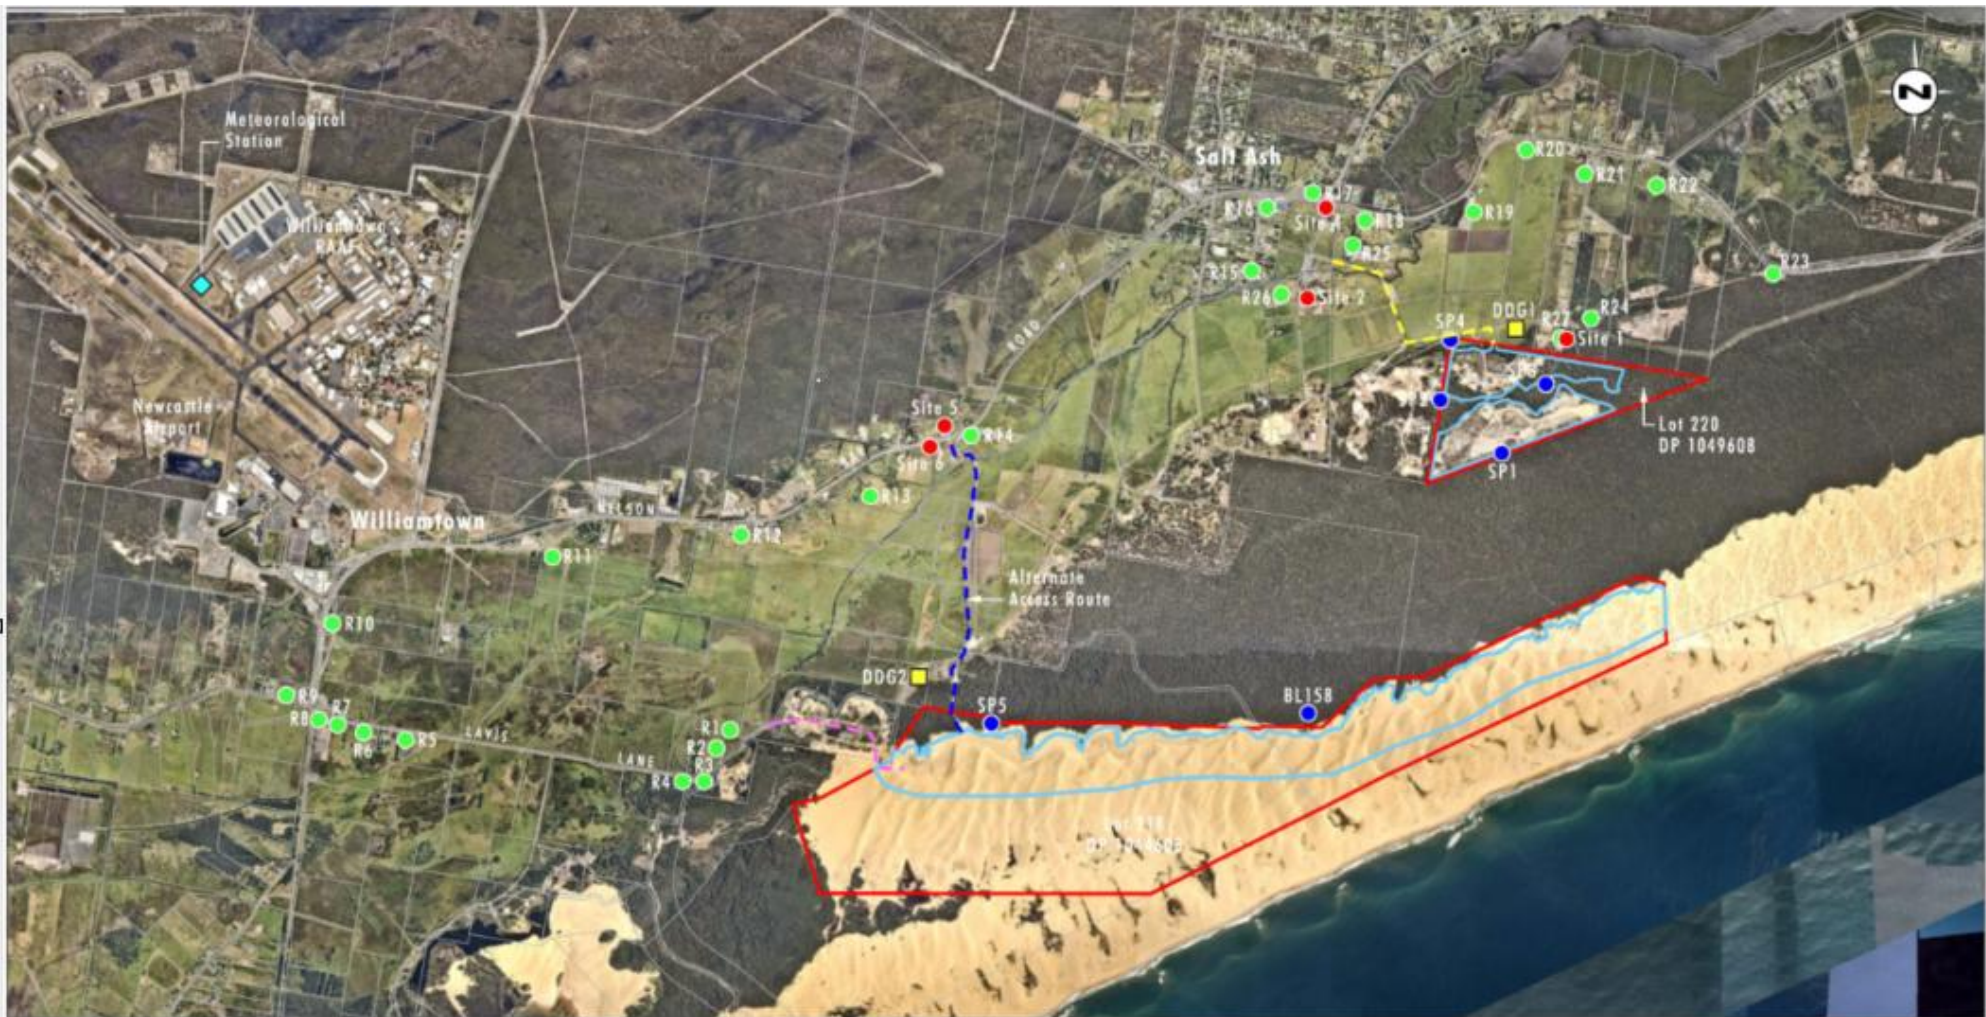
**Figure 6.1** shows the Mackas Sand environmental monitoring locations.

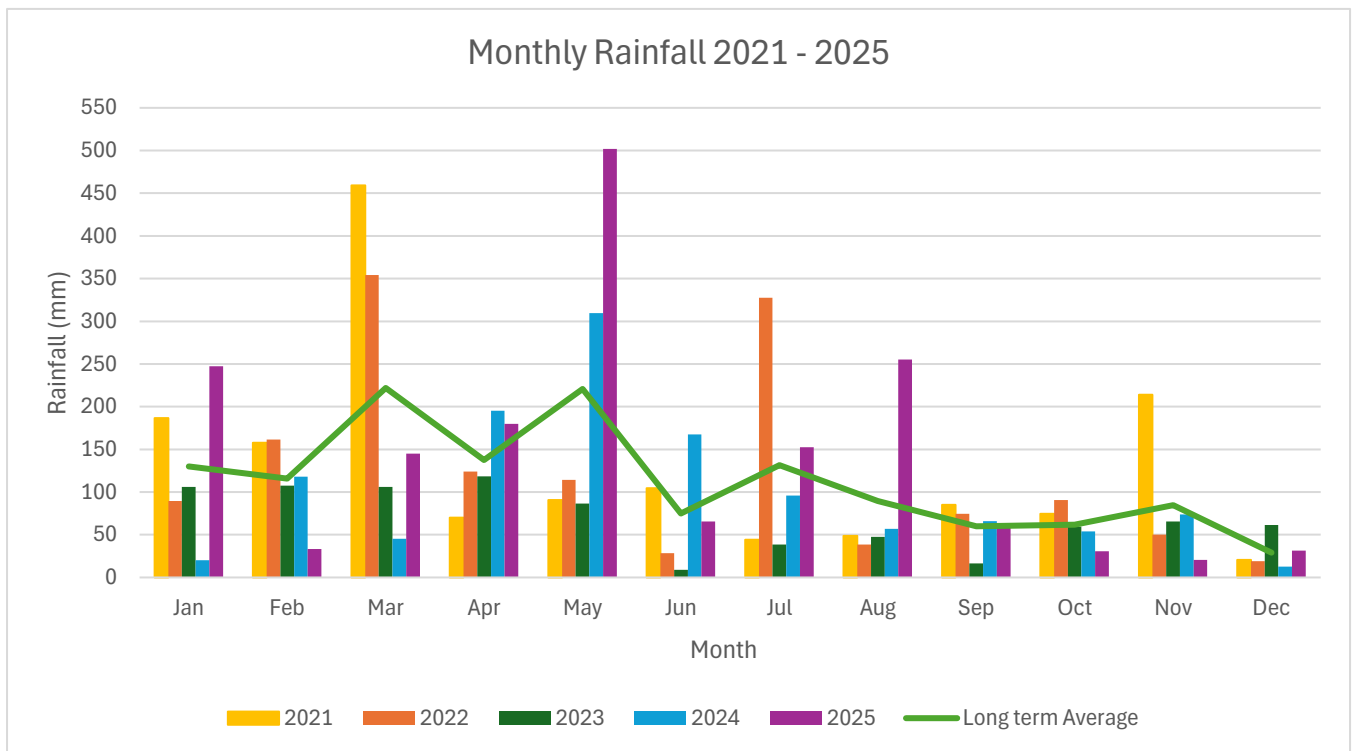
Figure 6-2 Monthly Rainfall 2021-2025

Figure 6-2 provides a comparison of monthly rainfall from 2021–2025.

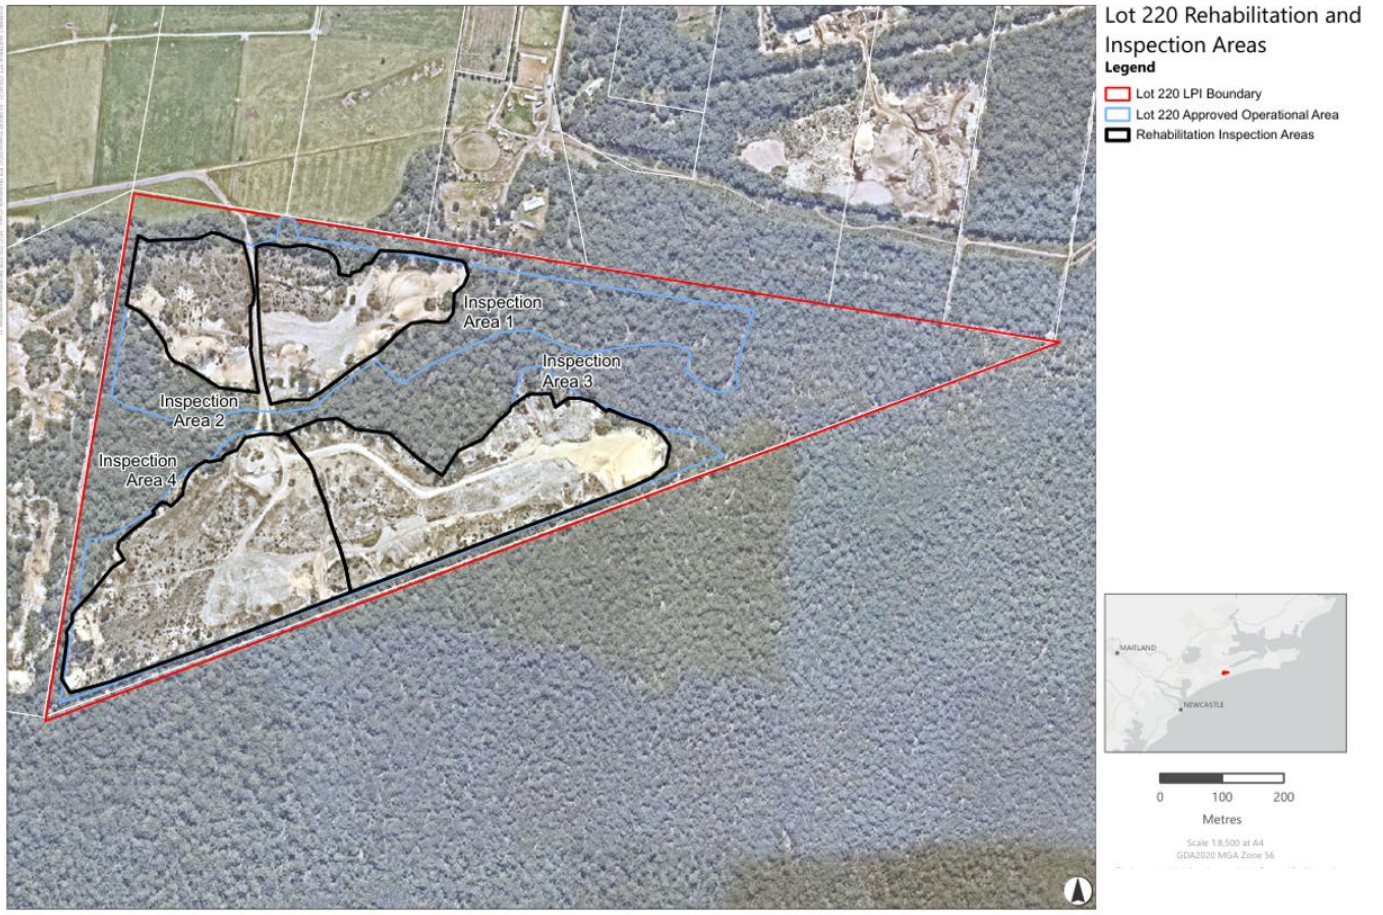
Figure 8-2 Lot 220 Rehabilitation and Inspection Area

Aspect	2025 Annual Inspection Findings	Proposed Actions for 2026
Landform	<ul style="list-style-type: none"> <li>The post extraction landform was found to have a minimum cover of 1m above MPG, per annual survey.</li> <li>No erosion or hazardous material present.</li> </ul>	Final batters on S/E side of Lot 220 to be revegetated.
Soil	<ul style="list-style-type: none"> <li>Topsoil re-spread on rehabilitation areas in Lot 220.</li> <li>Leaf litter layer is starting to form in Lot 220 rehabilitation, depending on age of rehabilitation vegetation established.</li> </ul>	No proposed improvements or additional actions for 2026. Continue current rehab.
Vegetation	<ul style="list-style-type: none"> <li>Revegetation area species includes species representative of <b>Coastal Sand Apple – Blackbutt Forest community</b> as planted.</li> <li>Second generation re-seeded plants evident in various locations. Trend likely to improve over time as vegetation and soils mature.</li> <li>More than 75% of trees appear to be healthy and growing. Very few trees show evidence of not surviving, or subject to insect attack or other issues.</li> </ul>	No proposed improvements or additional actions for 2026. Continue current rehab.

Fauna	<ul style="list-style-type: none"> <li>It was observed that mature tree stags were placed in rehabilitated areas for hollows/habitat, plus logs in place. As revegetation matures, understory species are recruiting into the area from adjoining forested areas.</li> </ul>	No proposed improvements or additional actions for 2026. Continue current rehab.
Bushfire Hazard	<ul style="list-style-type: none"> <li>Appropriate bushfire hazard controls have been implemented on the advice from the NSW Rural Fire Service</li> </ul>	No proposed improvements or additional actions for 2026. Continue current rehab.
